RAILWAY HOTEL AND LAWSON STREET SOUTH CAR PARKS

Review of Environmental Factors

Byron Bay Car Park Upgrade Works

Review of Environmental Factors
June 2018

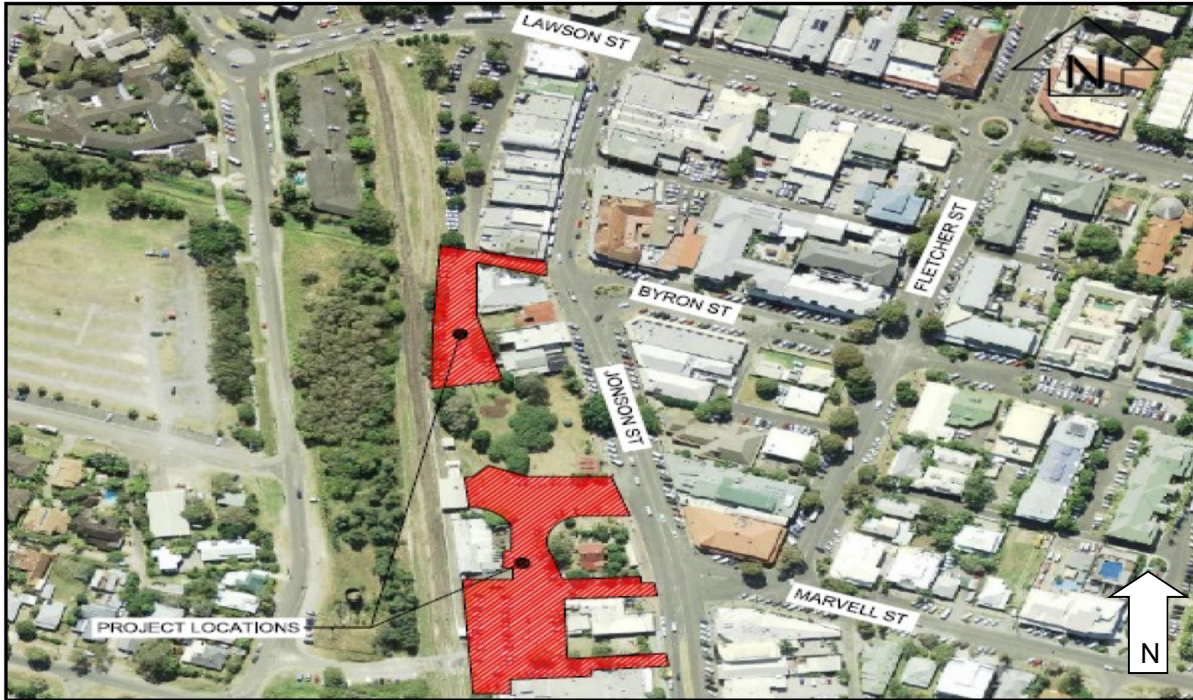
Figure 1: Location of Car Parks. Drainage work will be undertaken between these areas along the Rail Corridor. (Note: Illustrative only. Not to scale)

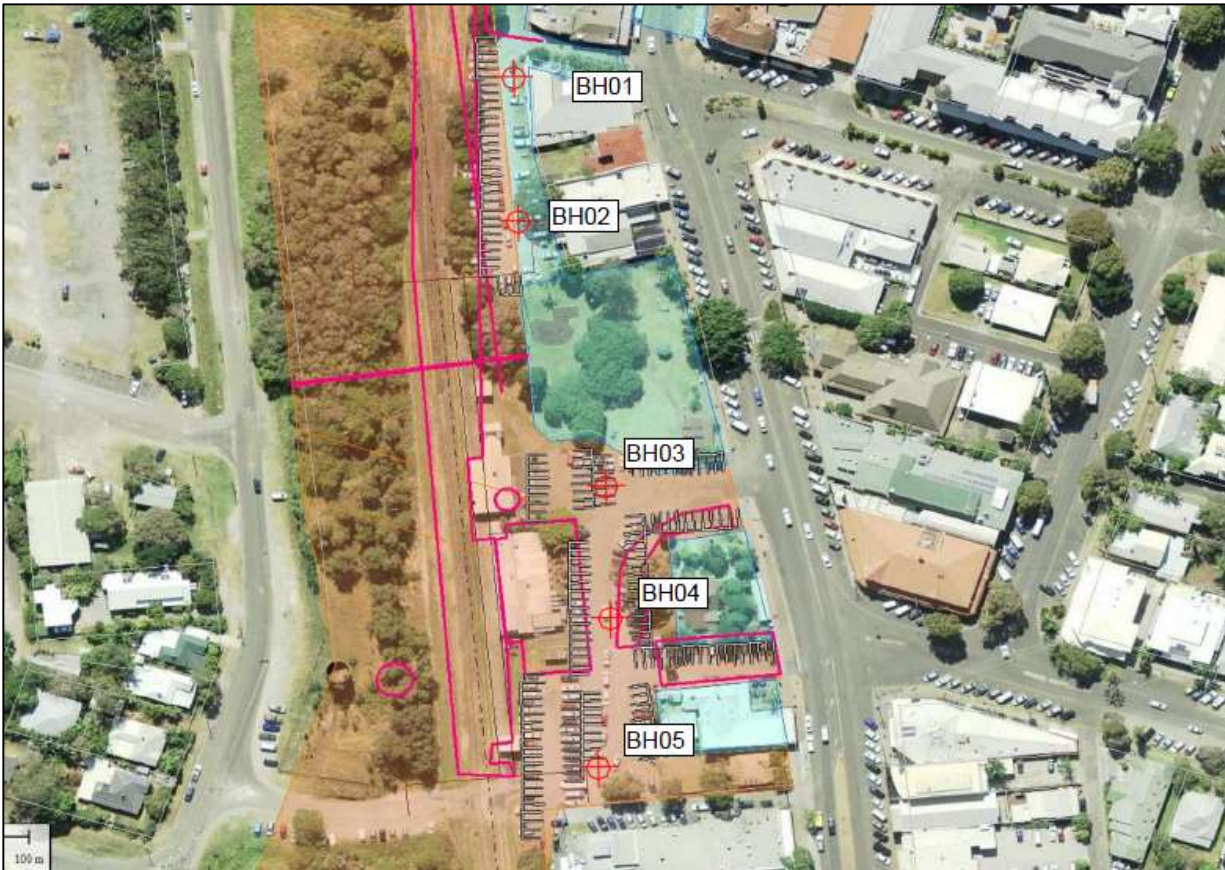
Figure 6: Aerial photograph showing borehole locations during geotechnical investigations.

Within the Railway Hotel Car Park, geotechnical investigations described the soils beneath the existing wearing course to comprise medium to course grained gravel between 0m to 0.15-0.3m with natural fine to medium grained sand to the depth of investigation at 1.6m.

Groundwater seepage was observed in test pits 1 and 2 at the time of the investigation at 1.2m below ground level. Ground water levels are transient and variations differing from those observed at the time of the investigation can be expected due to climatic effects, heavy rainfall and permeability of the soil strata.

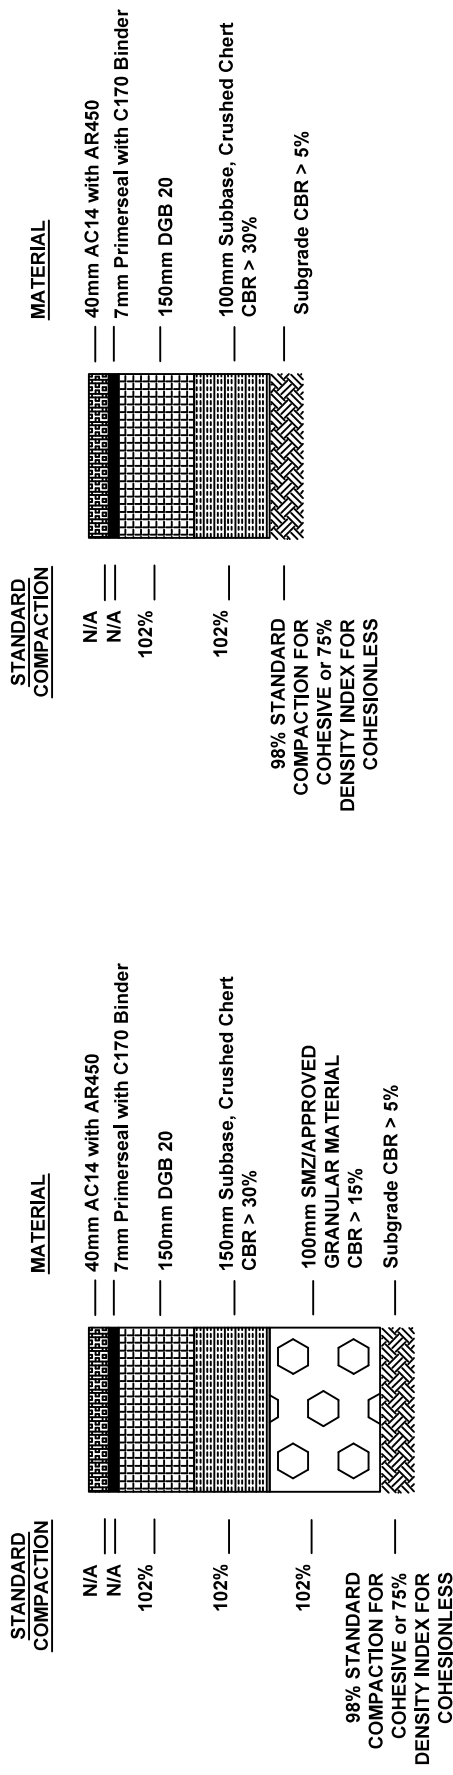
**PAVEMENT ARRANGEMENT
PROPOSED ROAD NTH CARPARK**

Pavement Type	DTL (DESA)	Design Subgrade CBR	Required cover over Subgrade Material (mm)	Design CBR Select Material	Required Cover Over Select Material	Design CBR	Required Cover (mm)	Proposed Pavement Design (mm)	
								Base	Select Material (CBR>30)
NTH Rails Carpark GF With Spray Seal	300,000	4.5	360	15	174	30	115	150	100
STH Rails Carpark GF With Spray Seal	300,000	10	224	15	174	30	115	150	0

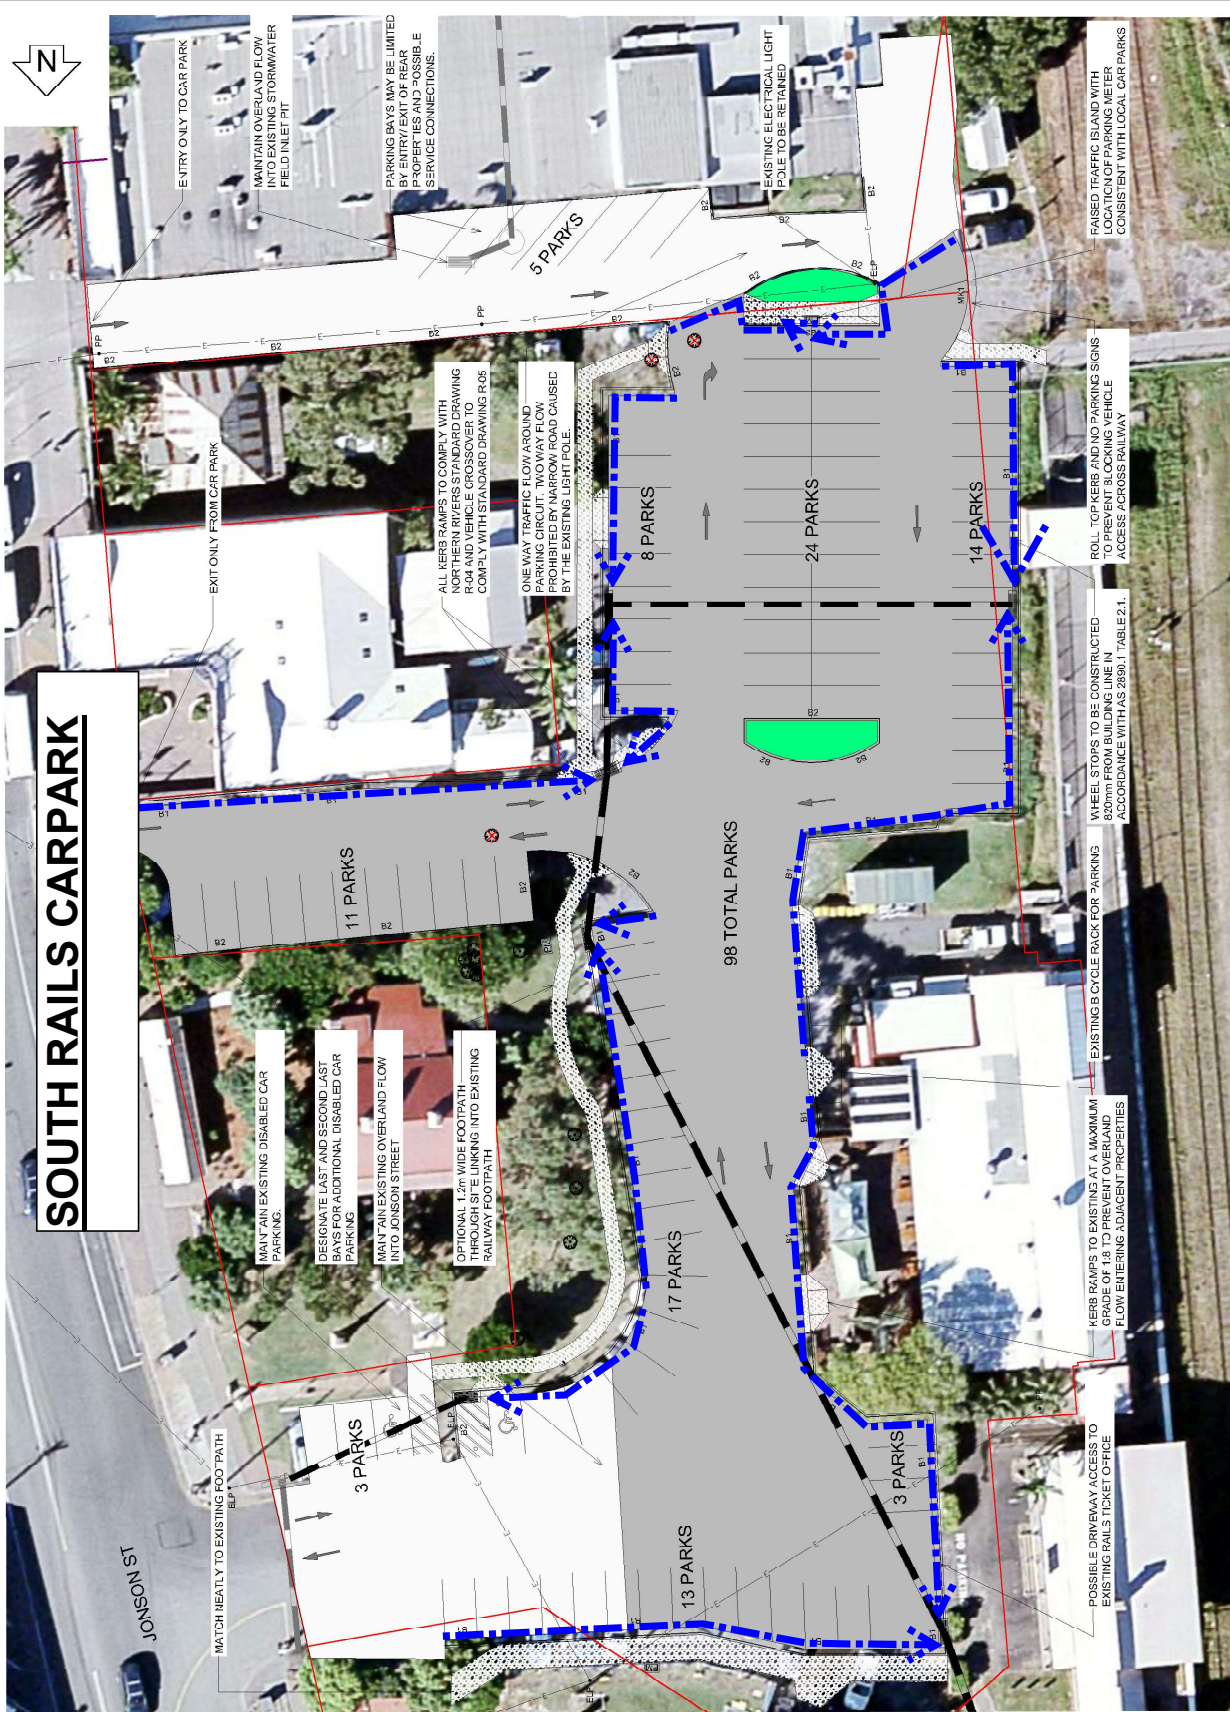
SOUTH RAILS CARPARK

ENTRY ONLY TO CAR PARK
 MAINTAIN OVERLAND FLOW INTO EXISTING STORMWATER FIELD INLET PIT
 PARKING BAYS MAY BE LIMITED BY ENTRY/EXIT OF REAR PROPERIES AND POSSIBLE SERVICE CONNECTIONS.
 EXISTING ELECTRICAL LIGHT POLE TO BE RETAINED
 RAISED TRAFFIC ISLAND WITH LOCATION OF PARKING METER CONSISTENT WITH LOCAL CAR PARKS
 ROLL TOP KERBS AND NO PARKING SIGNS TO PREVENT BLOCKING VEHICLE ACCESS ACROSS RAILWAY
 WHEEL STOPS TO BE CONSTRUCTED 820mm FROM BUILDING LINE IN ACCORDANCE WITH AS 2890.1 TABLE 2.1.
 EXISTING BICYCLE RACK FOR PARKING
 KERB RAMPS TO EXIST AT A MAXIMUM GRADE OF 1:8 TO PREVENT OVERLAND FLOW ENTERING ADJACENT PROPERTIES
 POSSIBLE DRIVEWAY ACCESS TO EXISTING RAILS TICKET OFFICE
 MATCH HEAVILY TO EXISTING FOOTPATH
 MAIN EXISTING DISABLED CAR PARKING.
 DESIGNATE LAST AND SECOND LAST BAYS FOR ADDITIONAL DISABLED CAR PARKING.
 MAINTAIN EXISTING OVERLAND FLOW INTO JONSON STREET
 OPTIONAL 1.2m WIDE FOOTPATH THROUGH ST. LINKING INTO EXISTING RAILWAY FOOTPATH

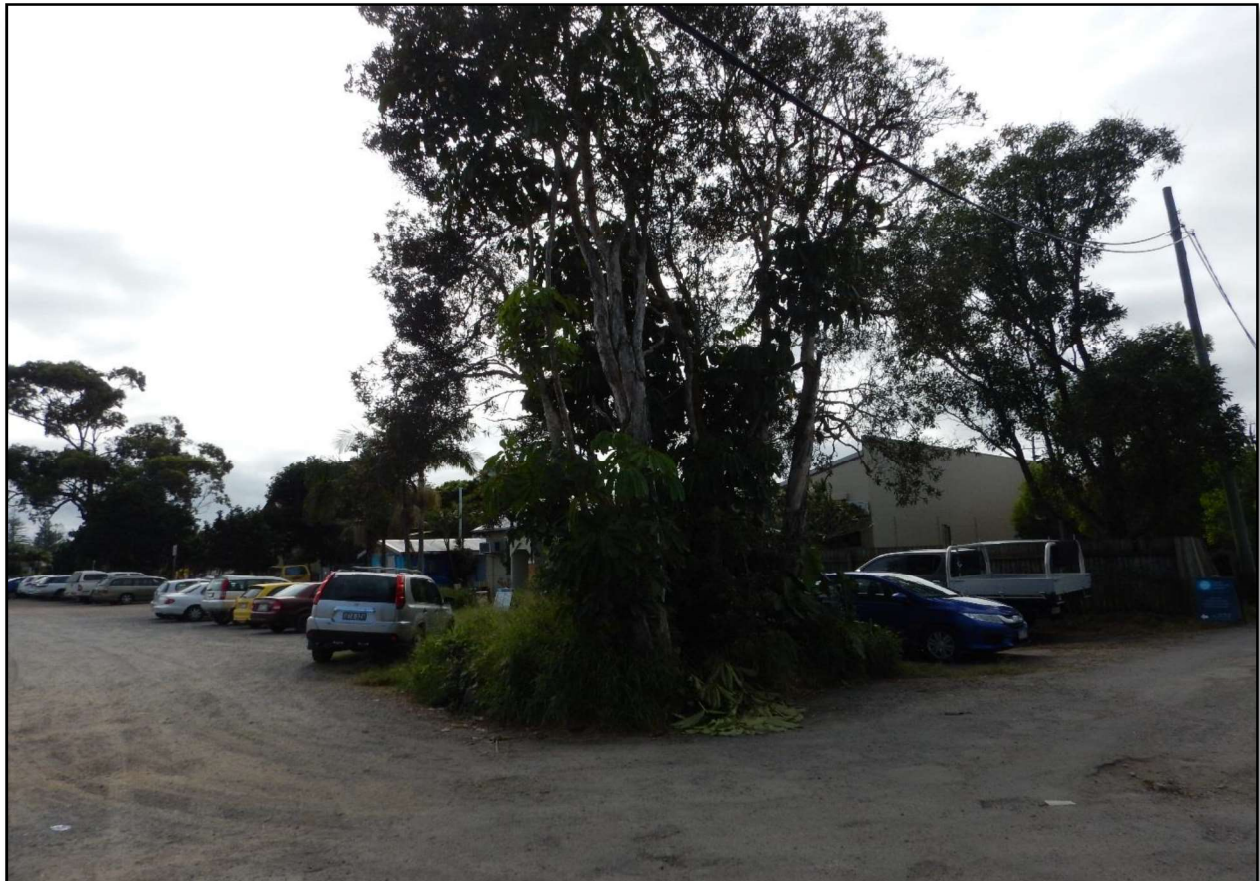
Figure 4 - Paperbark trees and Umbrella tree

Images for the identified trees have been also been provided below. Please note that the two (2) Paperbark and Umbrella tree are located in the same location.

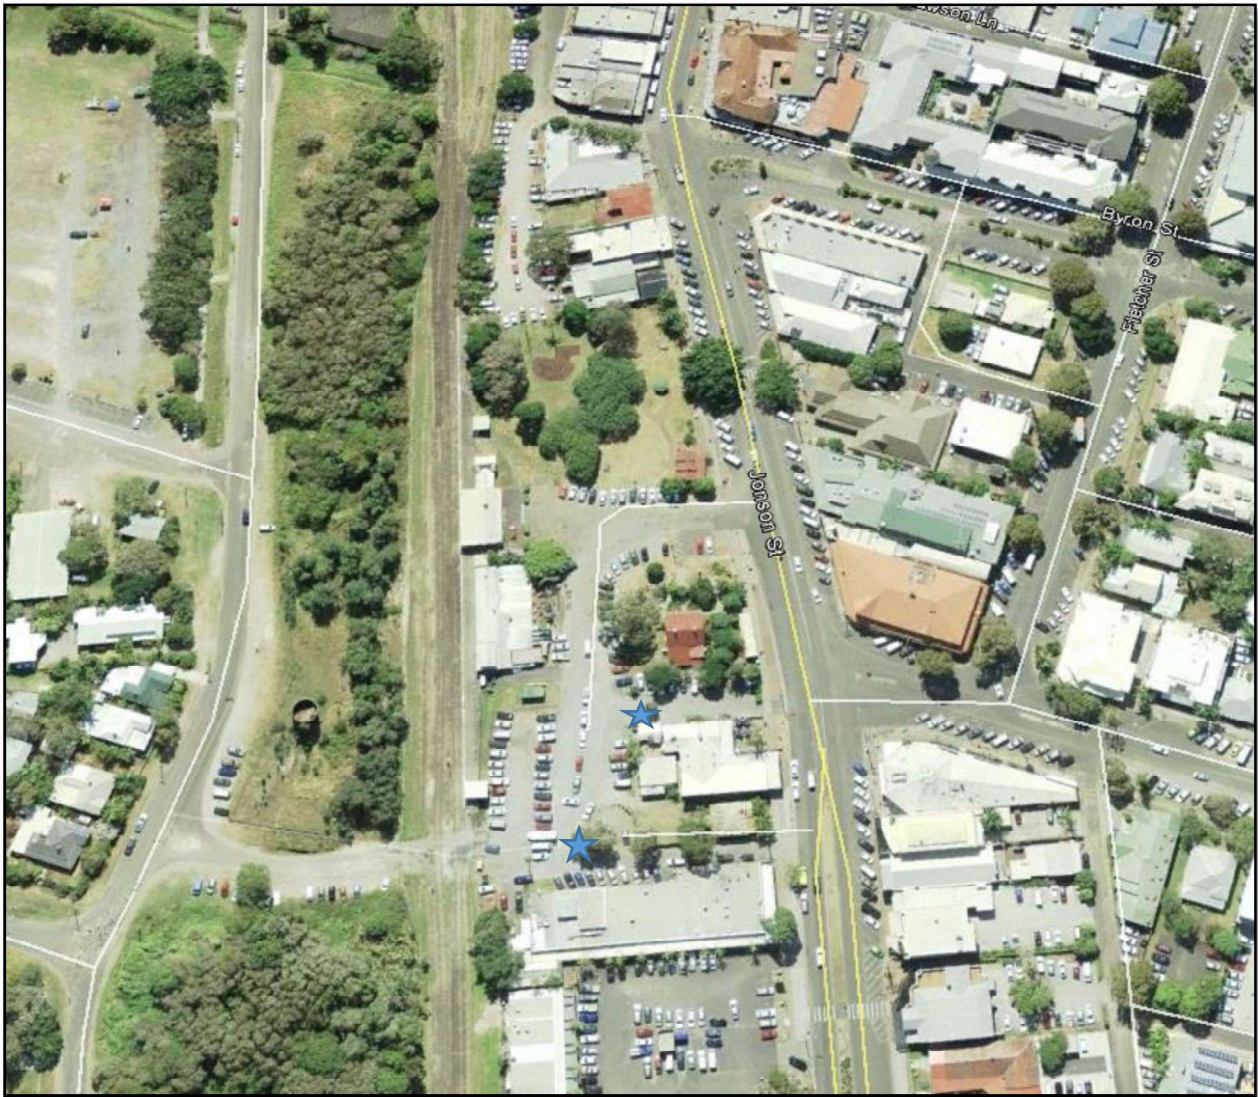
Figure 8 - Existing vegetation within locality

It is considered the proposed tree clearing is appropriate and will not cause an adverse impact on the existing environment. As seen in the figure below, the existing vegetation within the two car parks is not linked to other vegetation in the surrounding locality. Furthermore, the trees to be removed are not listed on any NSW endangered species list, with the Umbrella tree listed as a noxious weed by NSW Department of Primary Industries.

★ Location of subject trees

Areas where vegetation is proposed to be removed to facilitate the development are have been displayed in Figure 8 above. This plan identifies appropriate vegetation protection methods and addresses the necessary removal and retention of vegetation as described above. Strict implementation of the following methodologies is necessary to ensure vegetation nominated for retention is not damaged during construction works.

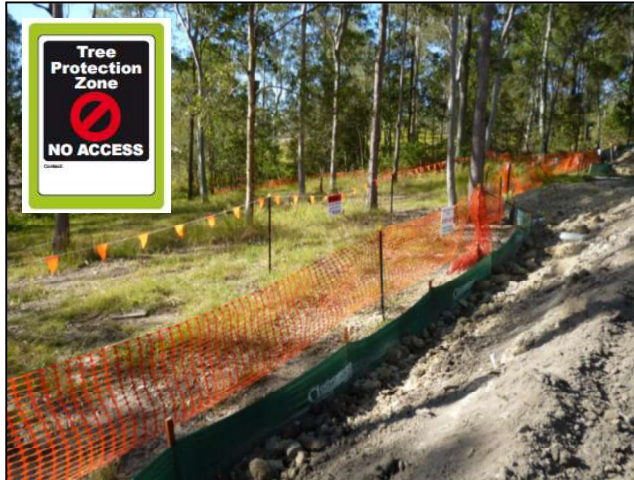
Element	Vegetation Management Plan
Objectives	<ul style="list-style-type: none"> • To remove the identified trees as specified previously within this report. • To retain other native and exotic trees around the perimeter of the local and existing unformed carparks. • To prepare and implement an Acid Sulfate Soil Management Plan (where necessary) and Sediment and Erosion Control Plan to manage potential impacts associated with earthworks.
Action	<ul style="list-style-type: none"> • Tree Protection Zones (TPZ) are to be clearly delineated on-site to ensure that all areas affected by this VMP are readily identifiable. • Vegetation to be retained must be delineated with tree protection fencing prior to commencement of tree clearing for easy identification (do not use permanent paints or similar). • Any works adjacent to trees nominated for retention must be undertaken by climbers to dismantle the tree. No machinery is permitted within the Tree Protection Zone. • Tree Protection Zones (TPZ) are to be established around the retained vegetation to ensure that machinery undertaking complete clearing over the site does not encroach within these areas. Exclusion fencing is to be erected in accordance with the below:

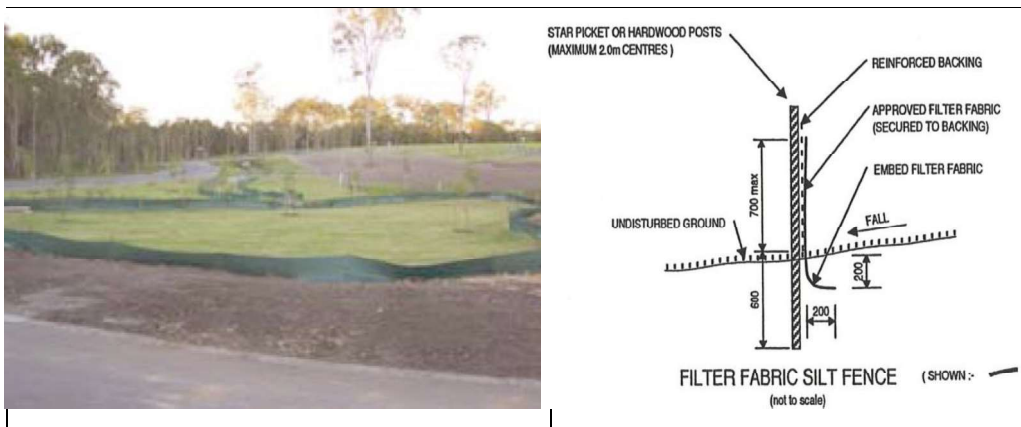
- During construction areas with batters adjacent to vegetation retention zones (including stormwater basins) are to incorporate sediment fencing generally as per the below:

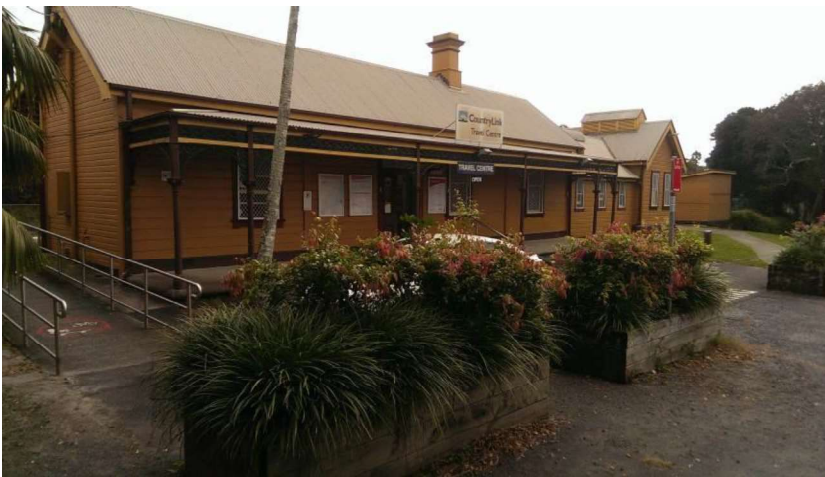
Photograph 4 The front elevation of the railway Station, looking north west, noting the planters.

The proposal retains these items and provides the new kerb in front of this alignment to restrict vehicle traffic from the main entry forecourt to the Station building.

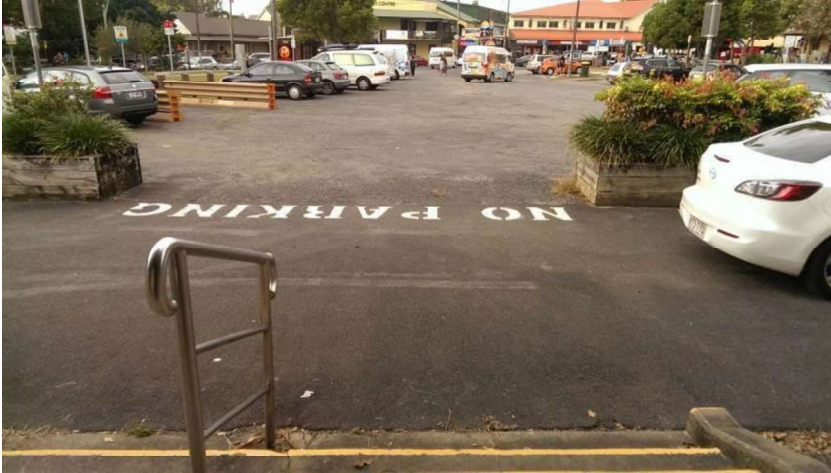
Photograph 5 View from the Station verandah looking east to Jonson Street.
No change is currently proposed to this area with the exception of the option for a driveway crossover to make the forecourt accessible for vehicle parking.

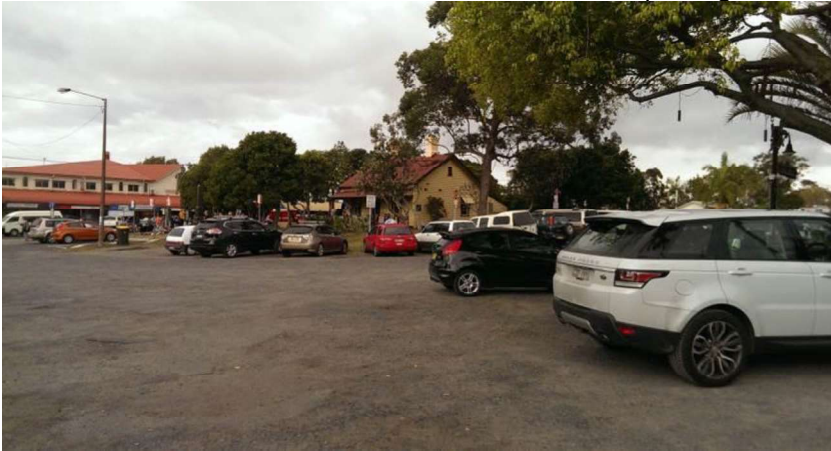
Photograph 6 View looking to the Station Master's cottage from the Station.
The proposal omits the corner parks to the right in the photo.

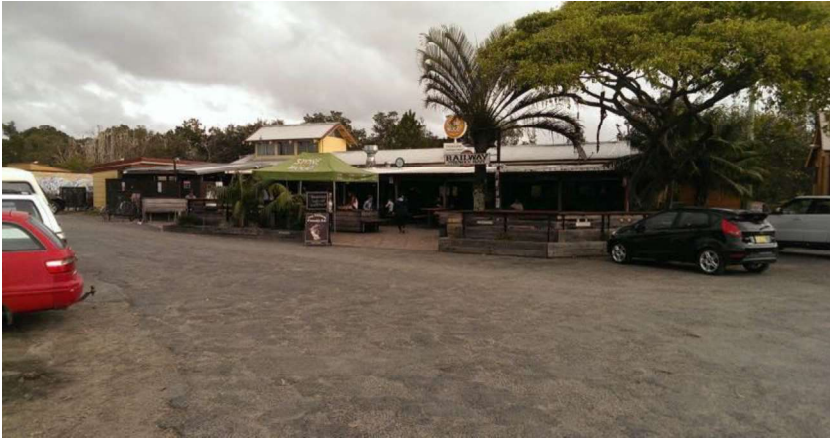
Photograph 8 View of the former refreshment Rooms now Bar, looking south west.
The proposal modifies the current staggered alignment in front of the planters to reflect the earlier perimeter evident in the photos and archive drawings.

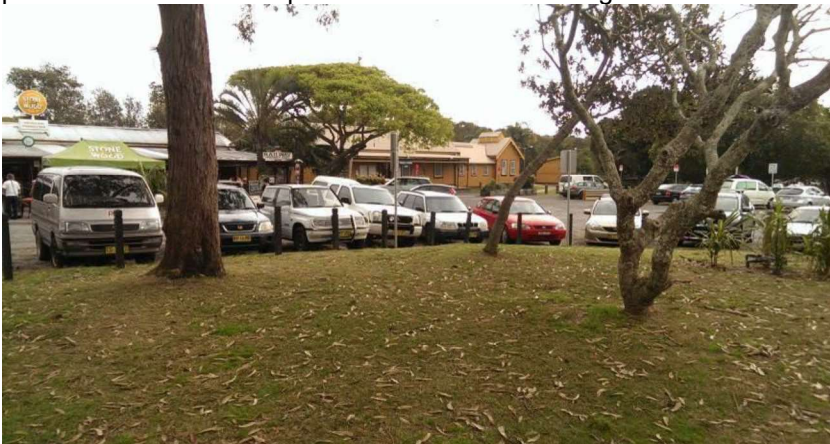
Photograph 9 View from the landscape to the western side of the Station Master's cottage.
The proposal includes a similar set of parked cars with a formed kerb and the optional pathway

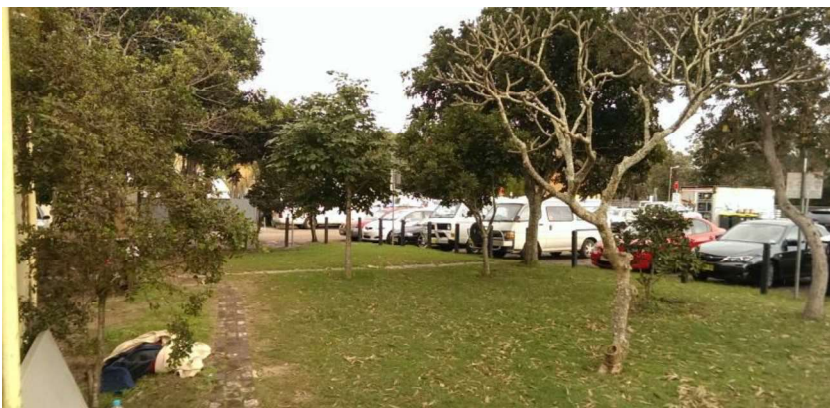
Photograph 10 View looking south from the landscape at the Station Master's cottage.
The proposal includes a similar set of parked cars with a formed kerb and the optional pathway and a blister at the junction which occurs at the end of the row and the lane out to Jonson Street.

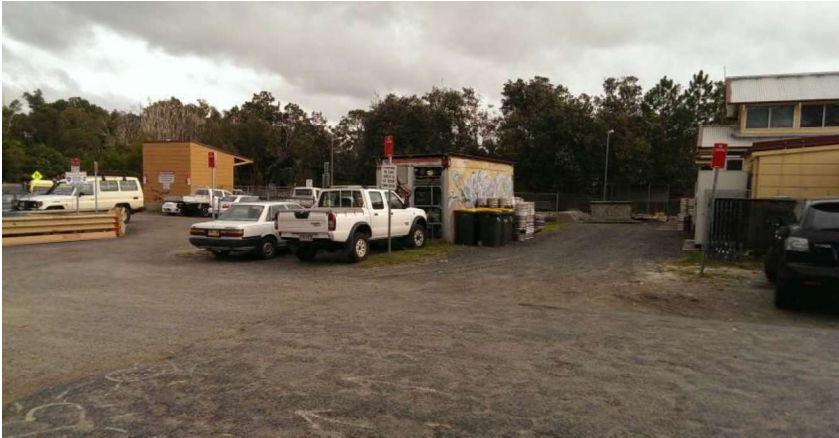
Photograph 11 View to the service yard at the side of the former Refreshment rooms, looking east towards the Platform and Waiting shed.
The Proposal includes an access crossover into the service yard which is currently not fenced.

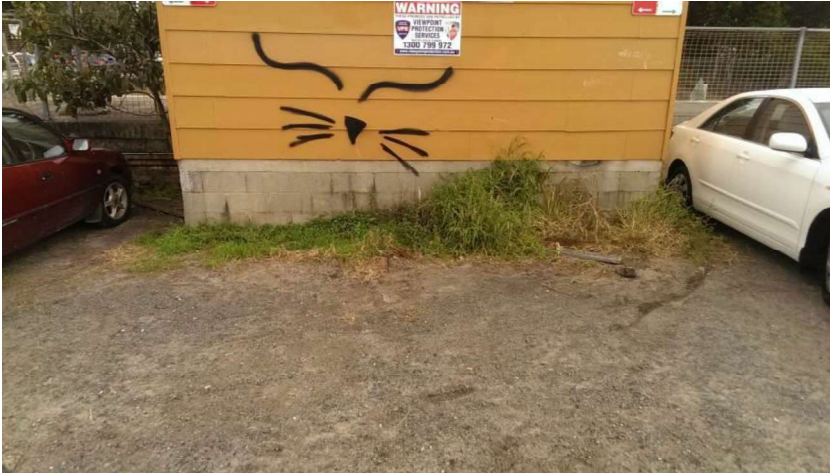
Photograph 14 The east elevation of the shed which requires protection
A strategy for combating graffiti is recommended including artwork and interpretation.

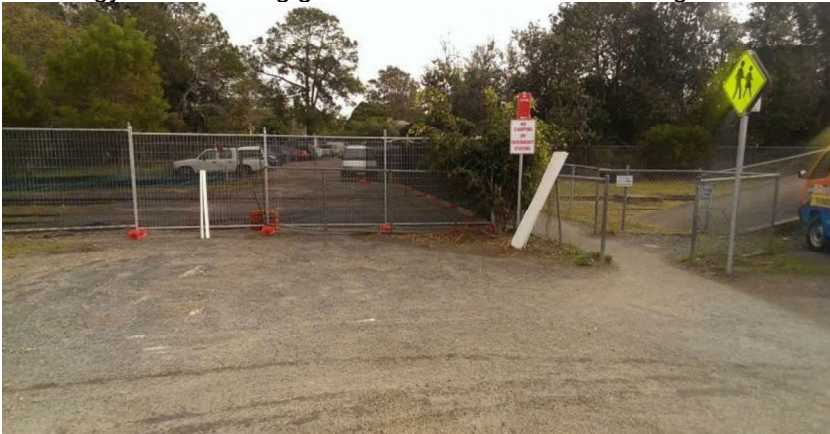
Photograph 15 View east of the level crossing and public path towards Butler Street.
The Proposal includes a roll top kerb to the crossing width, curved from the end of the fence.

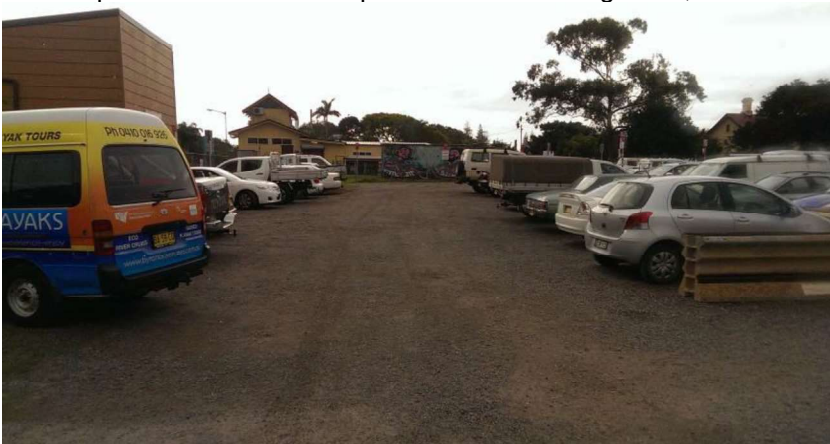
Photograph 16 View looking north with the line, Waiting shed and Refreshment rooms to the left.
The proposal includes a similar vehicle layout with three trees and landscaped ends.

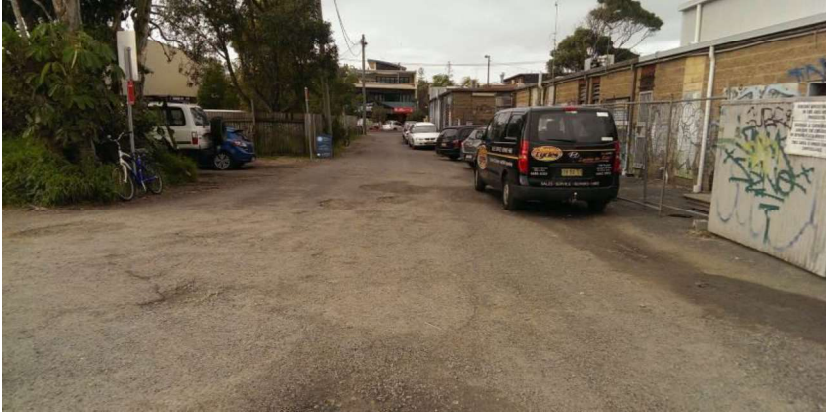
Photograph 20 View of the lane looking east
The Proposal includes 5 angled parking spaces to the right.

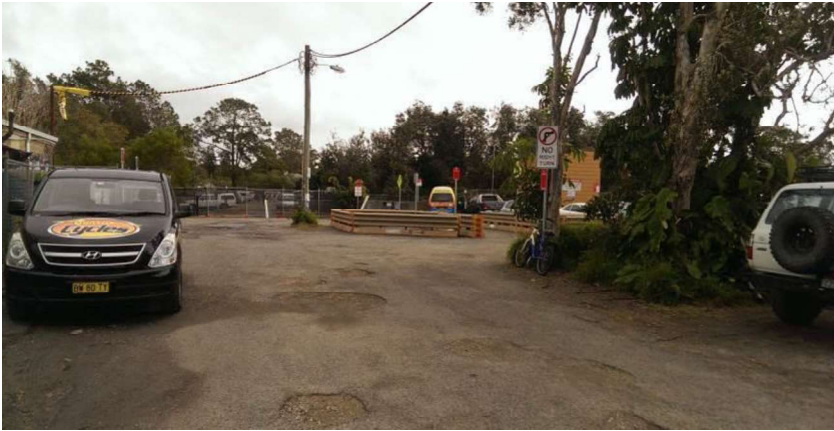
Photograph 21 View looking west down the Lane towards the level crossing.
The Proposal removes the trees to the right and provides a raised island where the existing temporary barriers are located.

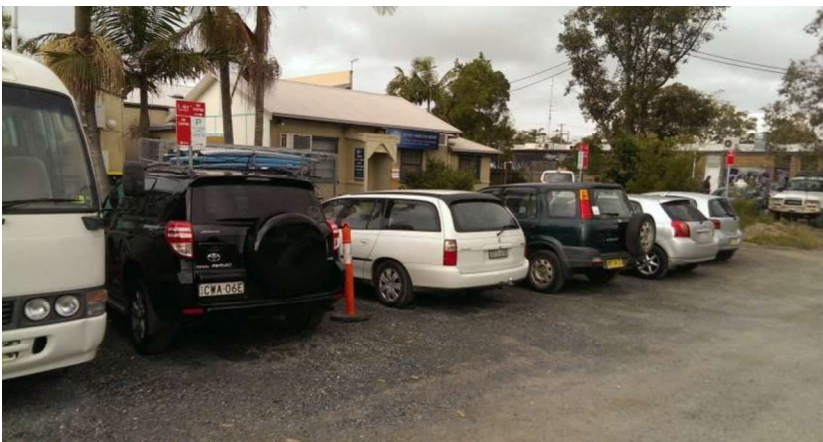
Photograph 22 View to the south east of the rear of the Jonson Street properties.
The Proposal includes a similar row of 8 parking spaces and path in front.

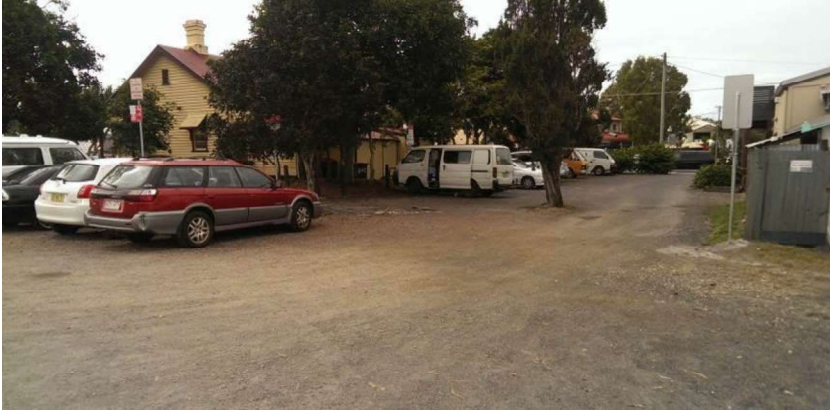
Photograph 23 View looking north east towards the Station Master's cottage and tree to be removed.

The Proposal includes blisters to each ends of the proposed pedestrian path linking the left and right shown above.

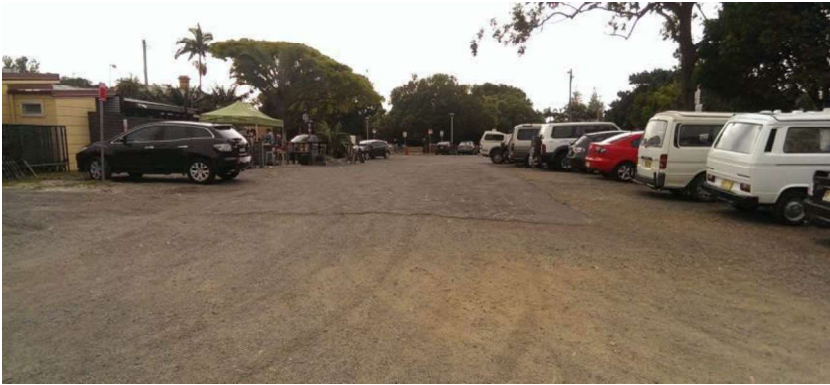
Photograph 24 View looking north at the central parking area.

The Proposal includes a row of parking spaces to the right and circulation only to the left above.

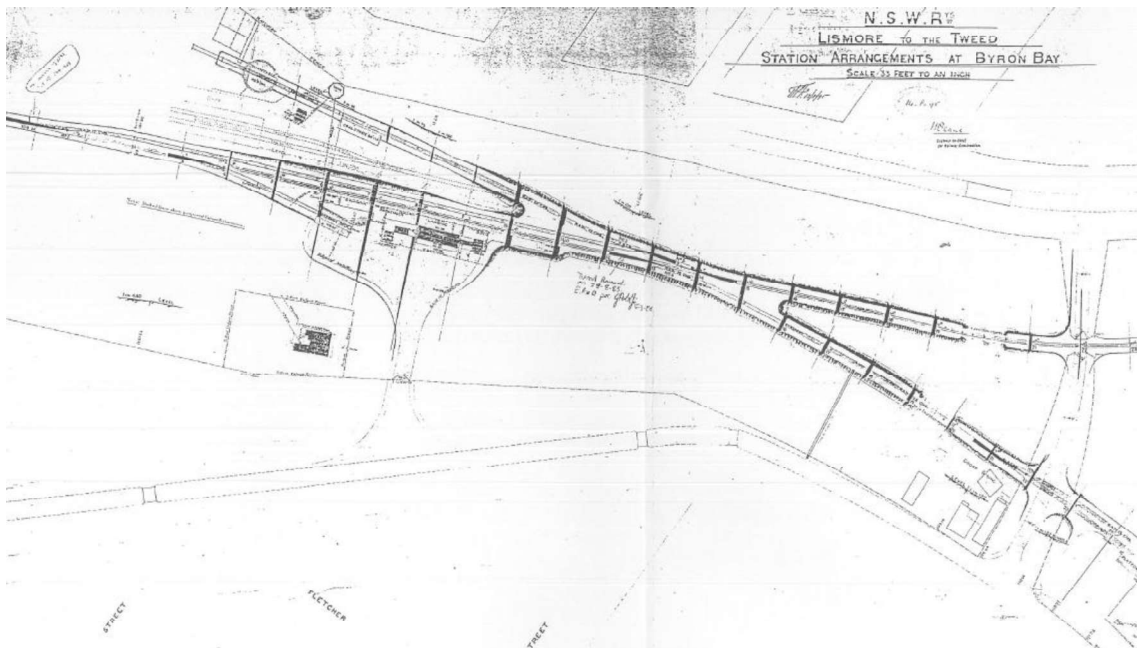
Figure 6 NSW Lismore to the Tweed, Station Arrangements at Byron Bay, 14.8.1895, Byron Shire Library Local Studies Collection

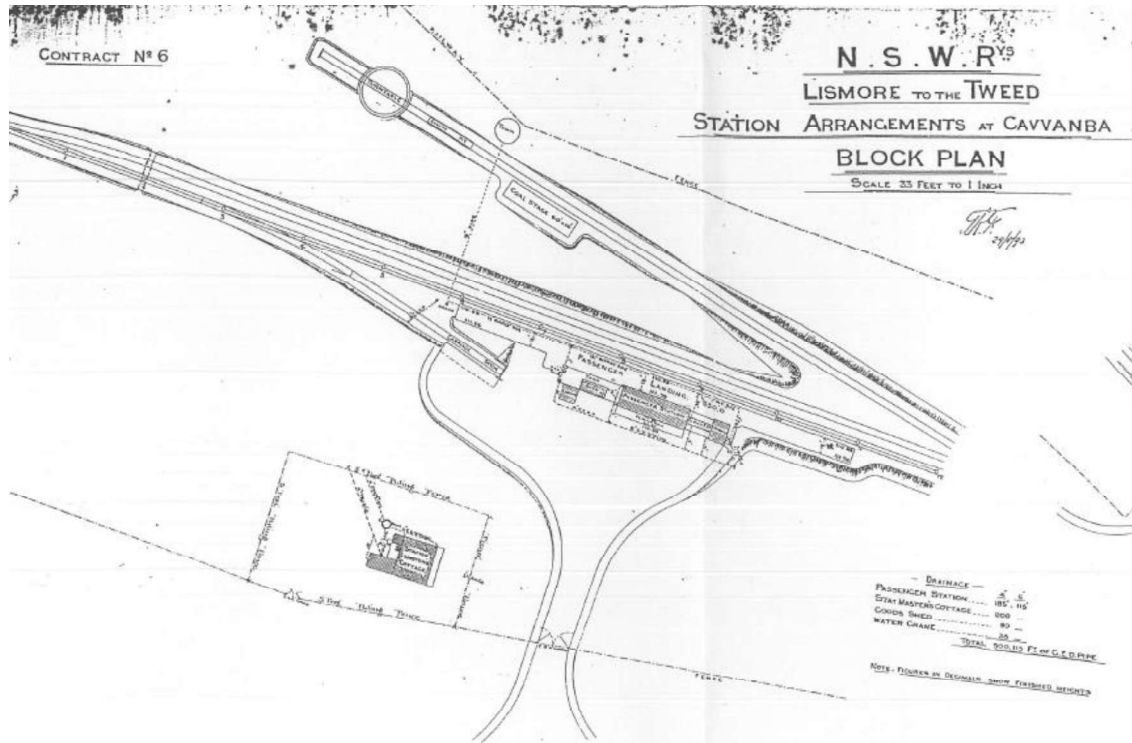
Figure 7 NSW Rail Lismore to the Tweed, Station Arrangements at Cavanba, Contract No. 6 Drawing No.2, 29.8.1893, Byron Shire Library Local Studies Collection

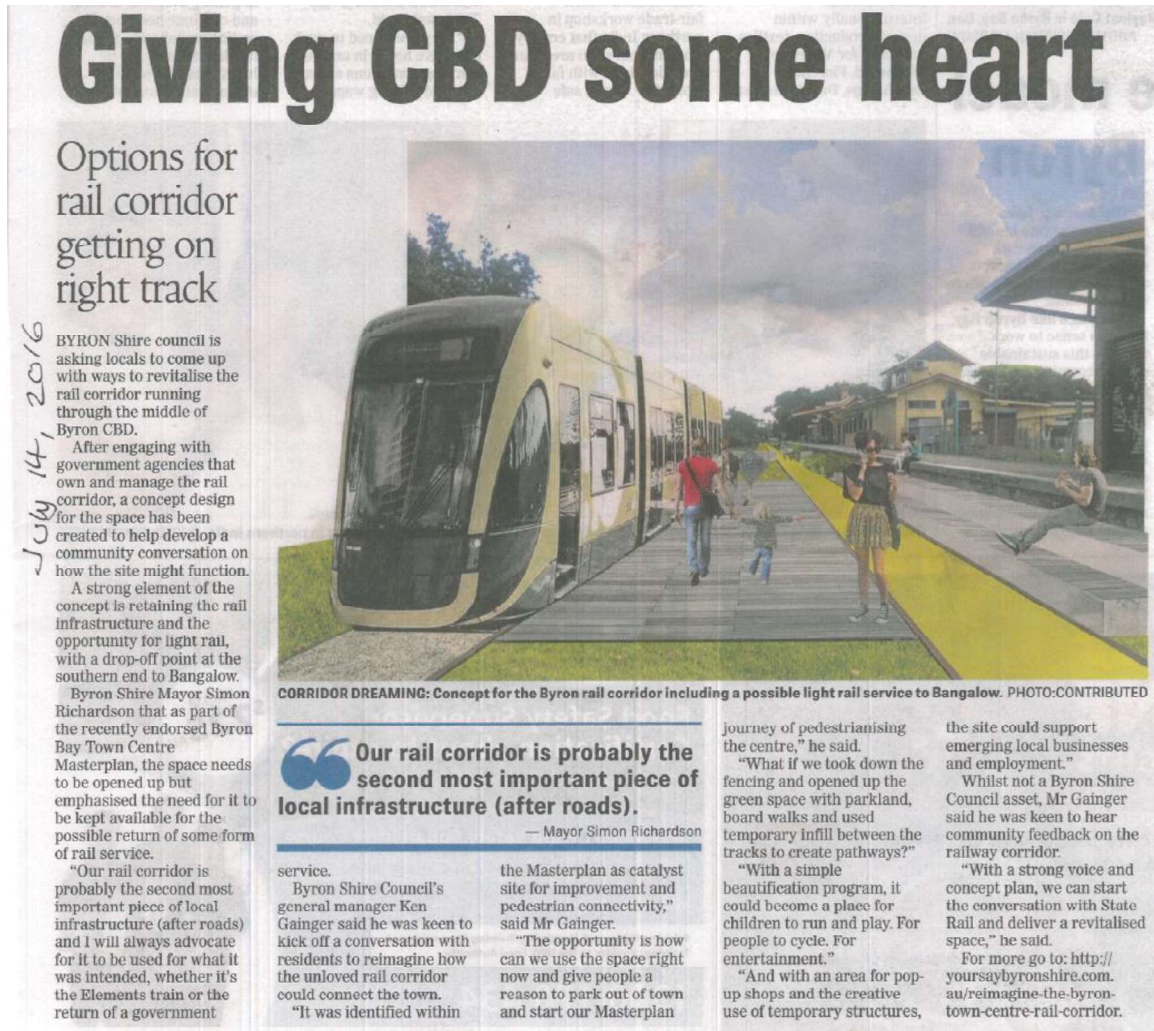
Figure 8 Recent history indicates that there is a distinct possibility of the line returning to a limited local use

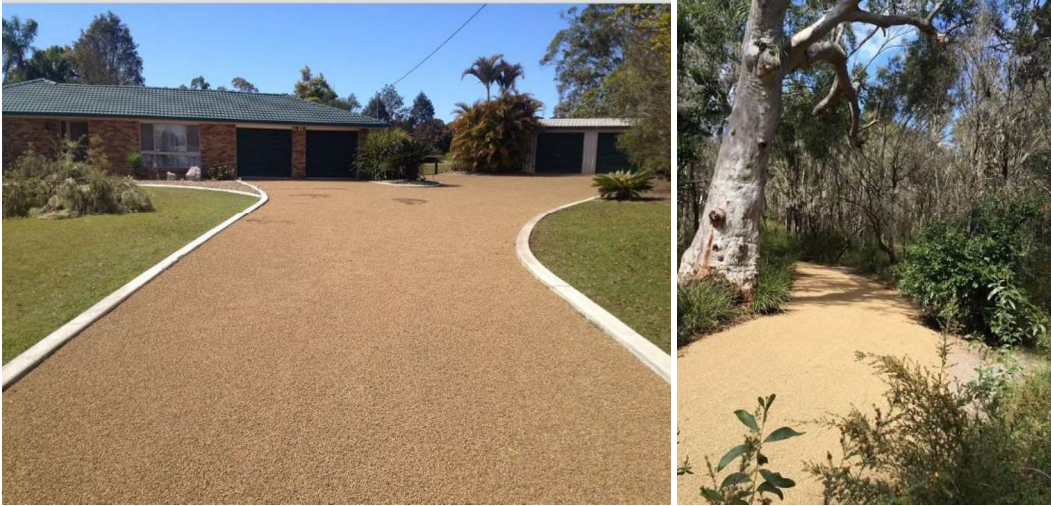
Figure 10 The Autumn gold aggregate finish in the Bushmates range from Statewide Bitumen

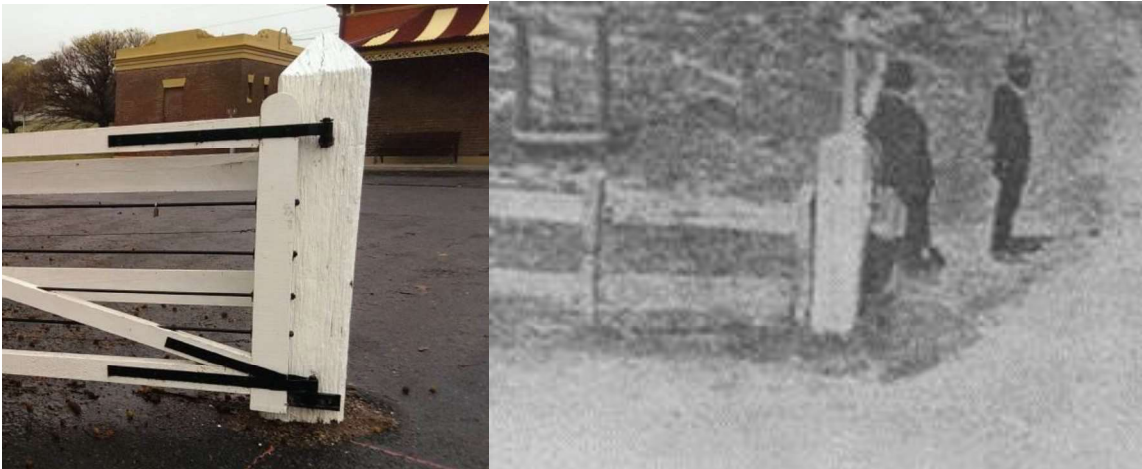
Figure 11 A typical example of a standard existing railway gate post (400x400mm *1400mmH) and the early site photograph of Byron Bay Railway Station entrance illustrating the fencing proposed for reinstatement as an interpretation and entrance marker.

- ❖ The introduction of interpretive posts in the location where the railway gates were located off Jonson Street, has been recommended. They should enhance pedestrian safety and modify vehicle speed.

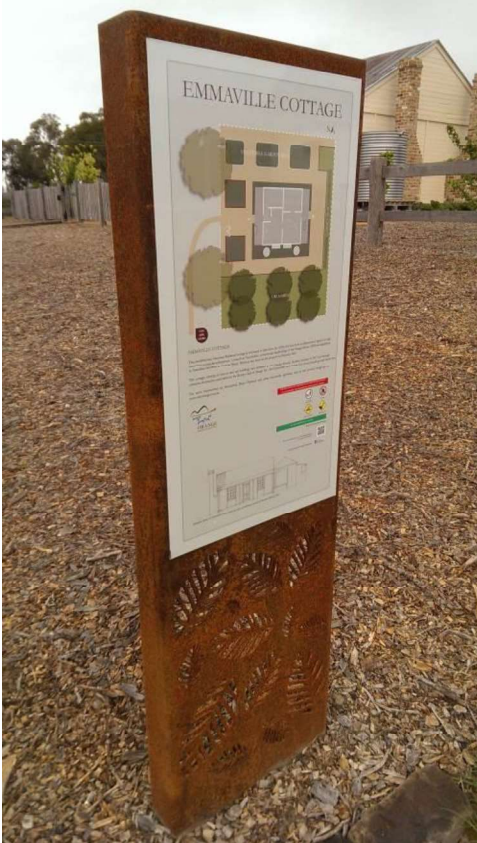
Figure 12 A typical interpretation panel using a vertical double sided format. Note the traditional timber post and rail fence.

- Negotiate the removal and replacement if required of the shipping container, to reinstate the setting;
- Provide a double sided interpretive panel in the landscaped blister at the southern end of the island parking layout, to interpret the heritage significance of the precinct.

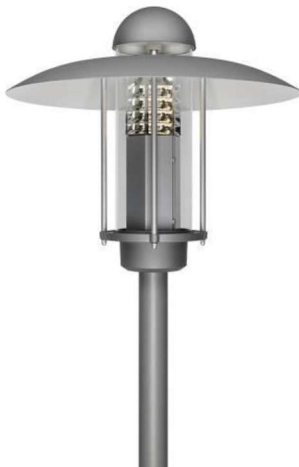
Figure 13 The City Light Elegance LED from Sylvania Lighting is a decorative post top luminaire featuring a domed circular aluminium canopy re-interpreting the form of the classic lantern shaped fixture. The luminaire features an LED module with either symmetrical or single sided asymmetrical distribution in 3,000k or 4,000k colour temperature options and would suit the vehicle areas within the Station precinct.

- Select and specify an appropriate post top light fitting similar to the City Light Elegance LED from Sylvania Lighting.
- Provide a replacement timber post and rail fence to the corner of the Refreshment room service yard, to reinstate the traditional elements of the setting;

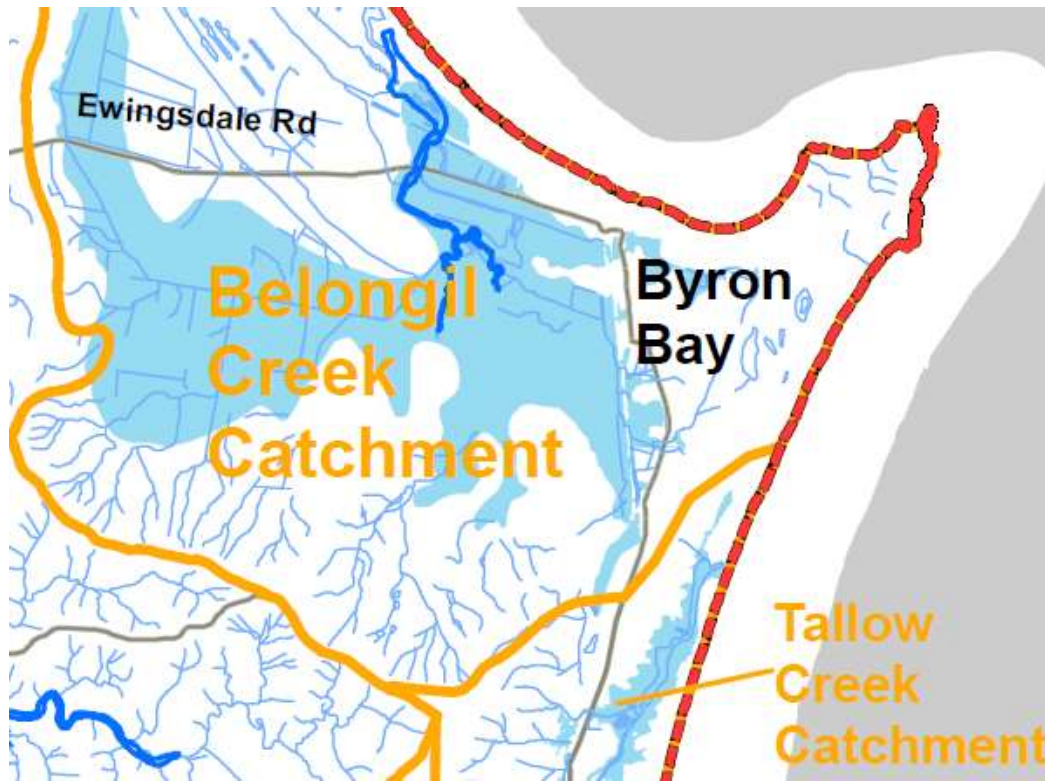
Figure 7: Belongil Creek Catchment Flood Risk - Byron Shire Council (LES 2008 Figure 10)

The site is located within the Belongil creek catchment and subject to flooding. A 2009 study undertaken on behalf of Byron Shire Council by SMEC modelled a number of scenarios factoring in climate change effects (Figure 7).

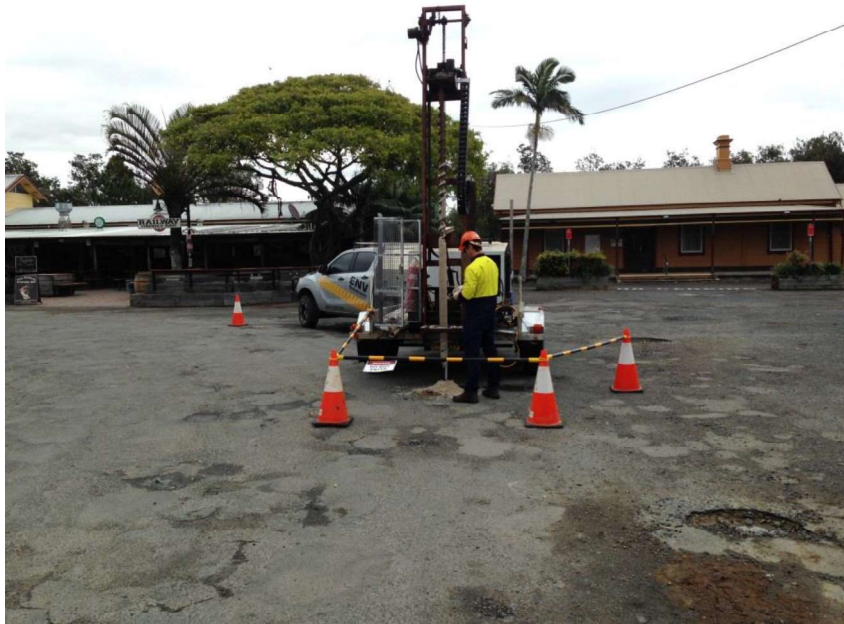
Plate 2: Example drill material sample.

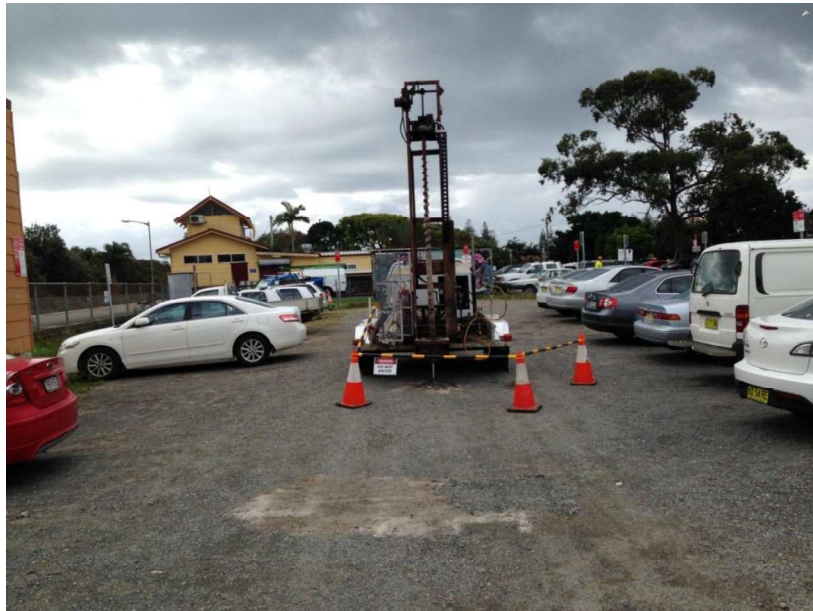
Plate 4: Drill rig with previous sample site in foreground
