RAILWAY HOTEL AND LAWSON STREET SOUTH CAR PARKS

Review of Environmental Factors

Byron Bay Car Park Upgrade Works

Review of Environmental Factors
June 2018

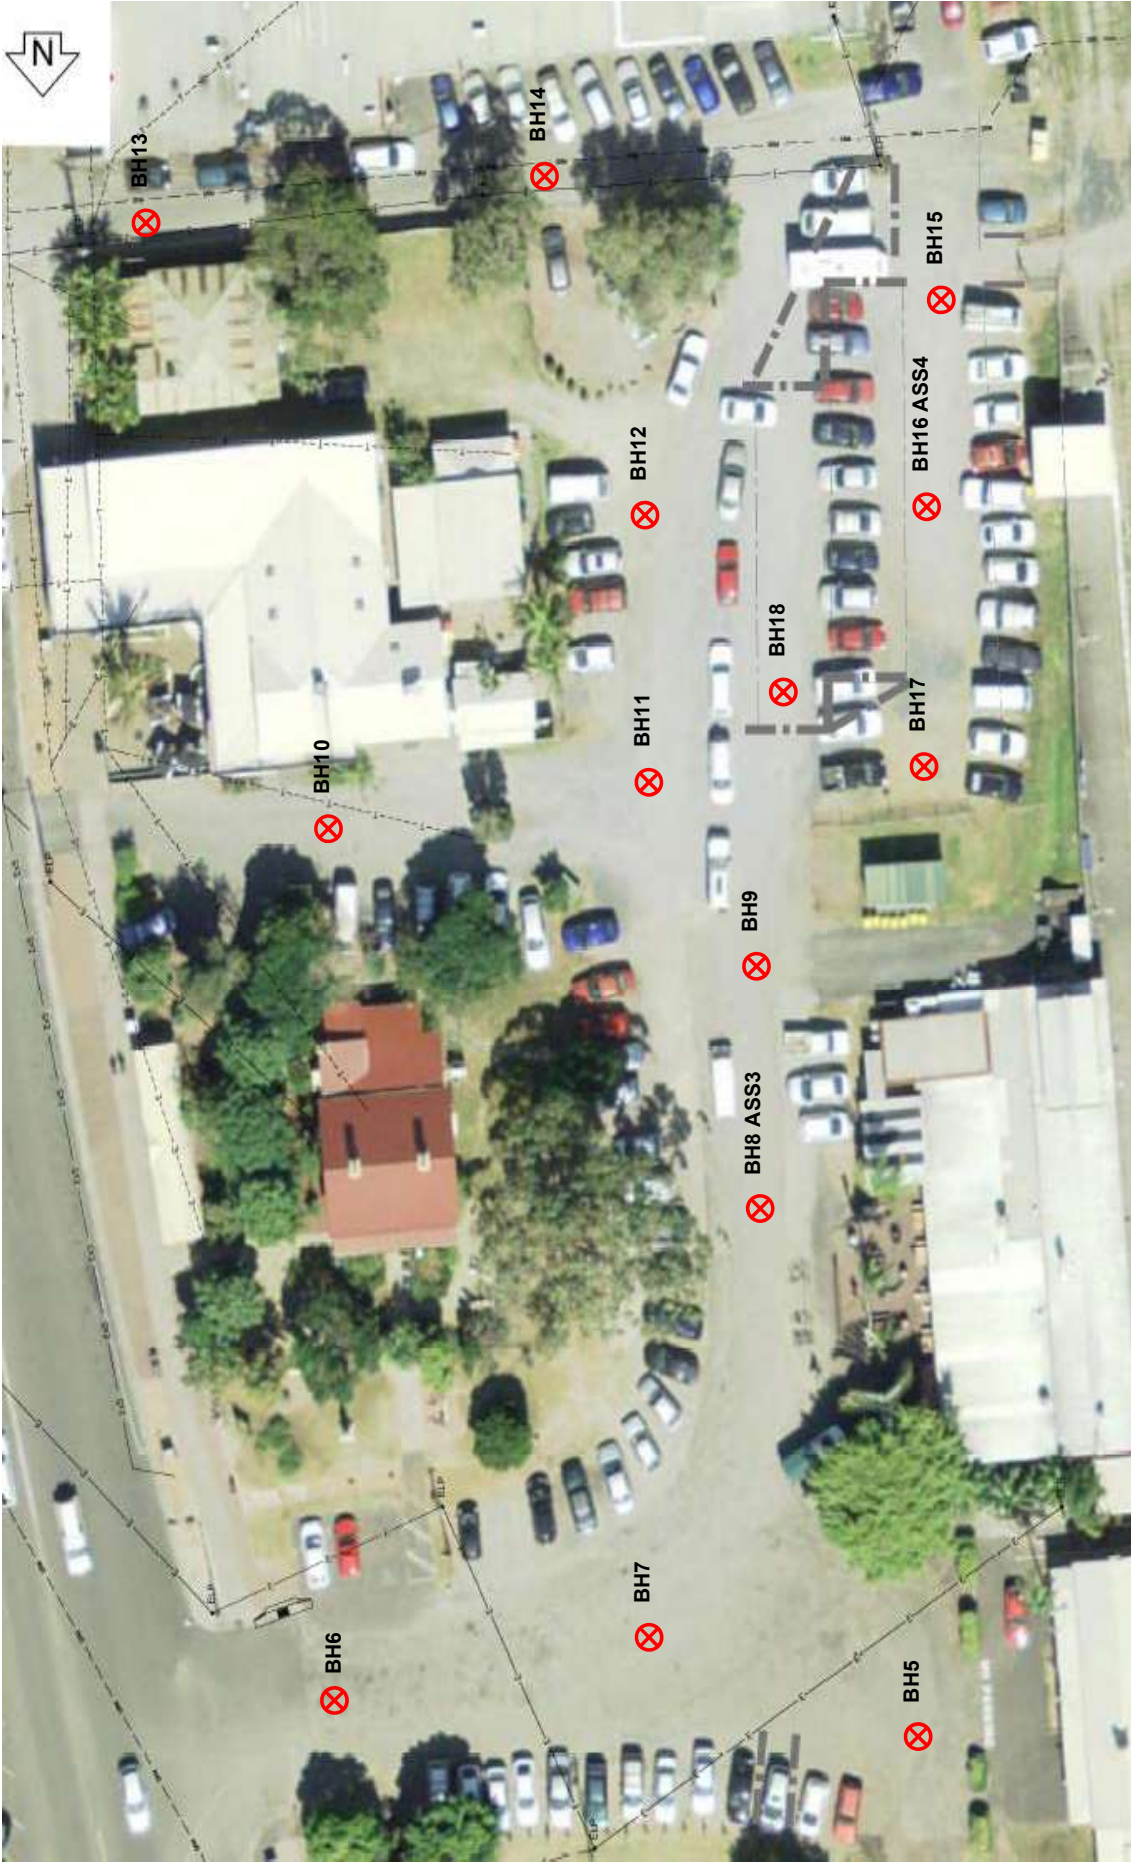
**FIGURE 1: Sampling Plan – Site Assessment
 Lot 1 DP 1001454– Railway Hotel Carpark**
 Imagery Courtesy of Six Maps 201

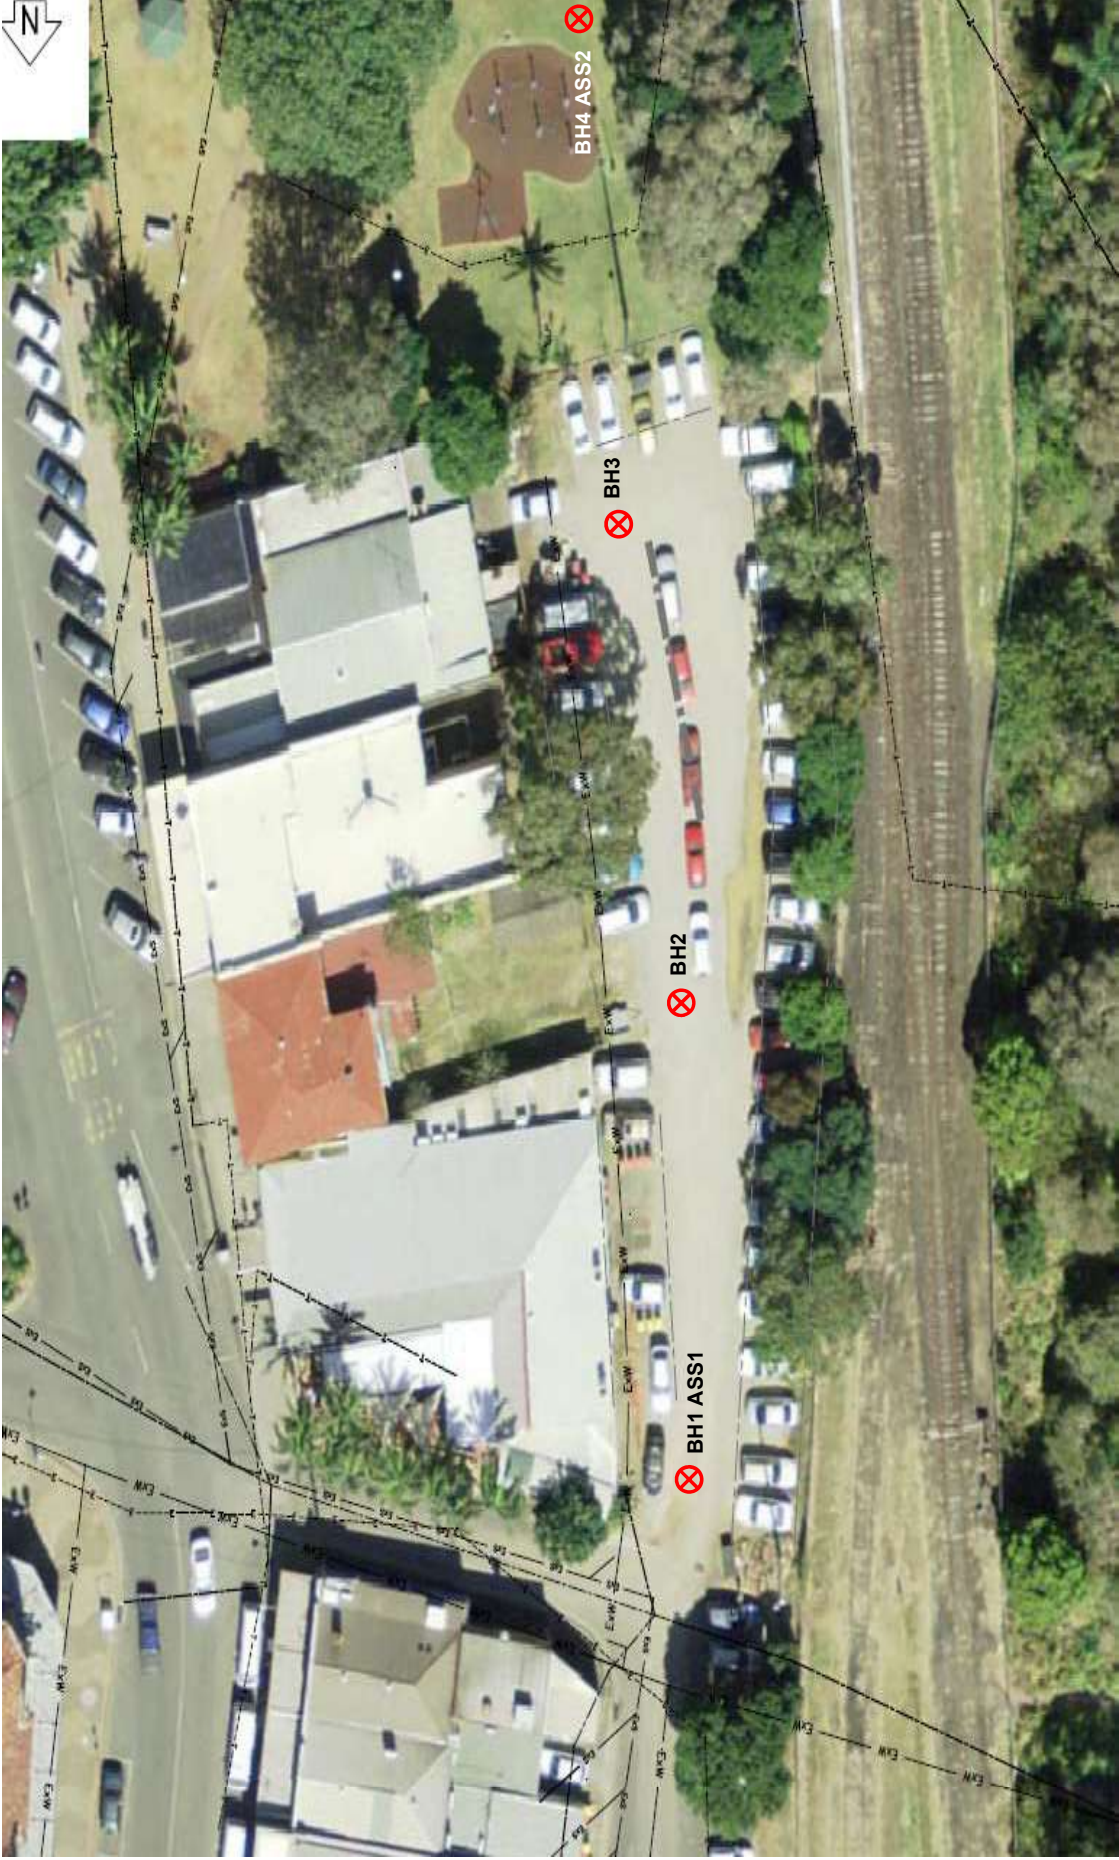
FIGURE 1: Sampling Plan – Soil Validation
Lot 3 DP 827049 – Railway Hotel Carpark
 Imagery Courtesy of Six Maps 201

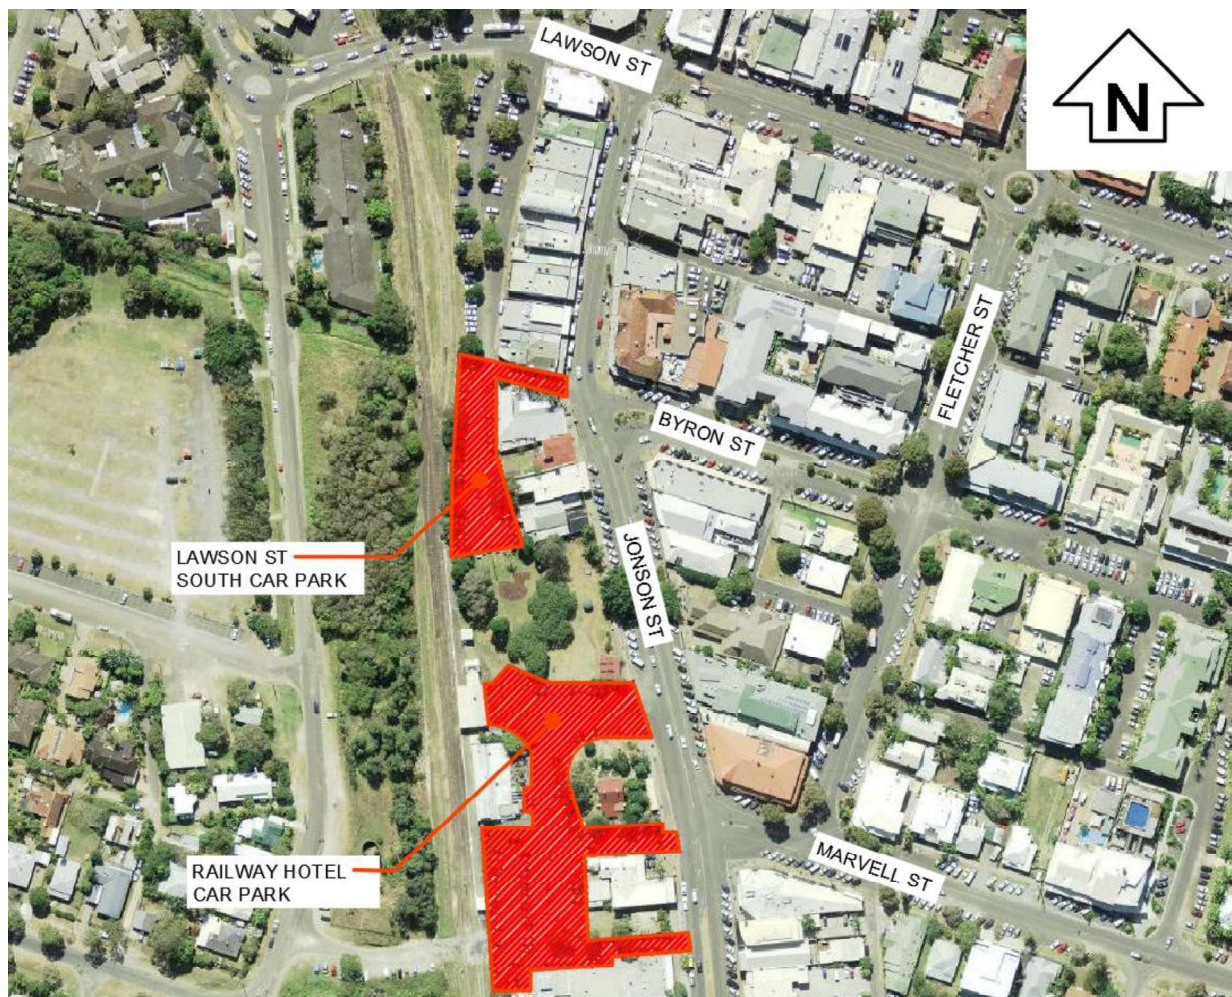
Figure 1 – Proposed Development Site

The subject site comprises two car parks separated by Railway Park centrally (figure 1) and is located at Byron Bay, NSW within the Byron Shire Council (BSC) local government area. The Car park here in described as the Railway Hotel Car Park is located to the South of Railway Park and Lawson St South Car Park is located to the North. Formal parking allocation exists for only a portion of the Railway Hotel Car Park and none exists for Lawson Street South. As such, unregulated parking has developed over time and encompasses parts of the Railway corridor, Railway Park legally described as Lot 2 DP827049, Council land described as Lot 3 DP827049, John Holland Rail Land described as Lot 1 DP1001454, and privately owned land described as Lot 5 DP619224. The existing space currently used for parking has a total area of 5700m² including 1330m² for Lawson St South Car Park and 4350m² for the Railway Hotel Car Park and is located centrally to Byron's Central Business District. Some of the key surrounding buildings and infrastructure include parkland, a hotel, Information Centre, heritage listed buildings, Jonson Rd and adjacent sealed car park.

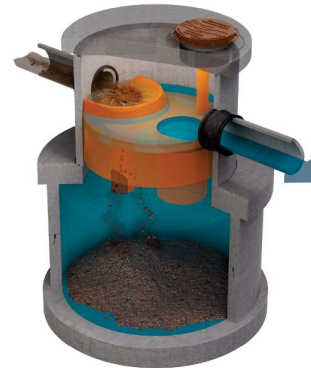
Figure 2 – HumeCeptor® system operation during high flow conditions

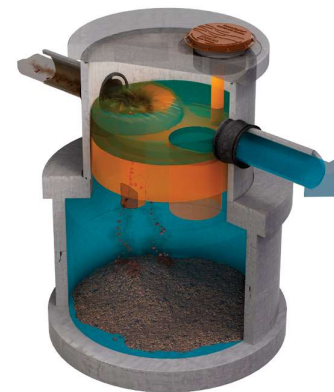
Figure 3 – HumeCeptor® system variations
