# Denistone Station Upgrade

# TREE SURVEY

ARBORICULTURAL IMPACT ASSESSMENT & TREE PROTECTION PLAN

**Denistone Station**  
**Transport Access Program (TAP)**  
Version v4

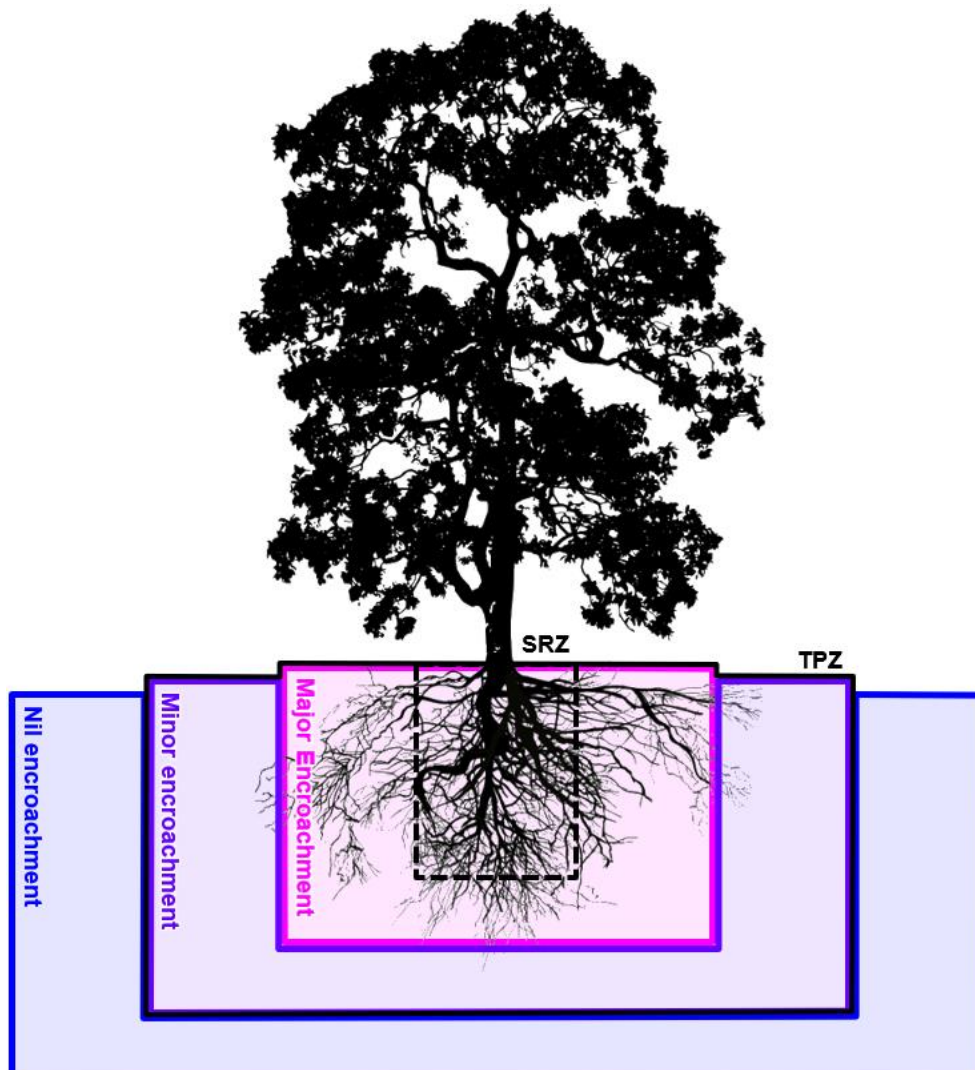
Figure 2: Three (3) levels of encroachment

Encroachment within the TPZ is acceptable, providing that the arborist can demonstrate that the tree will remain viable. There are three (3) levels of encroachment (as defined by AS 4970-2009):

- **Nil encroachment (0%):** No encroachment within the TPZ.
- **Minor encroachment (<10%):** The encroachment is less than 10% of the TPZ.
- **Major encroachment (>10%):** The encroachment is greater than 10% of the TPZ.

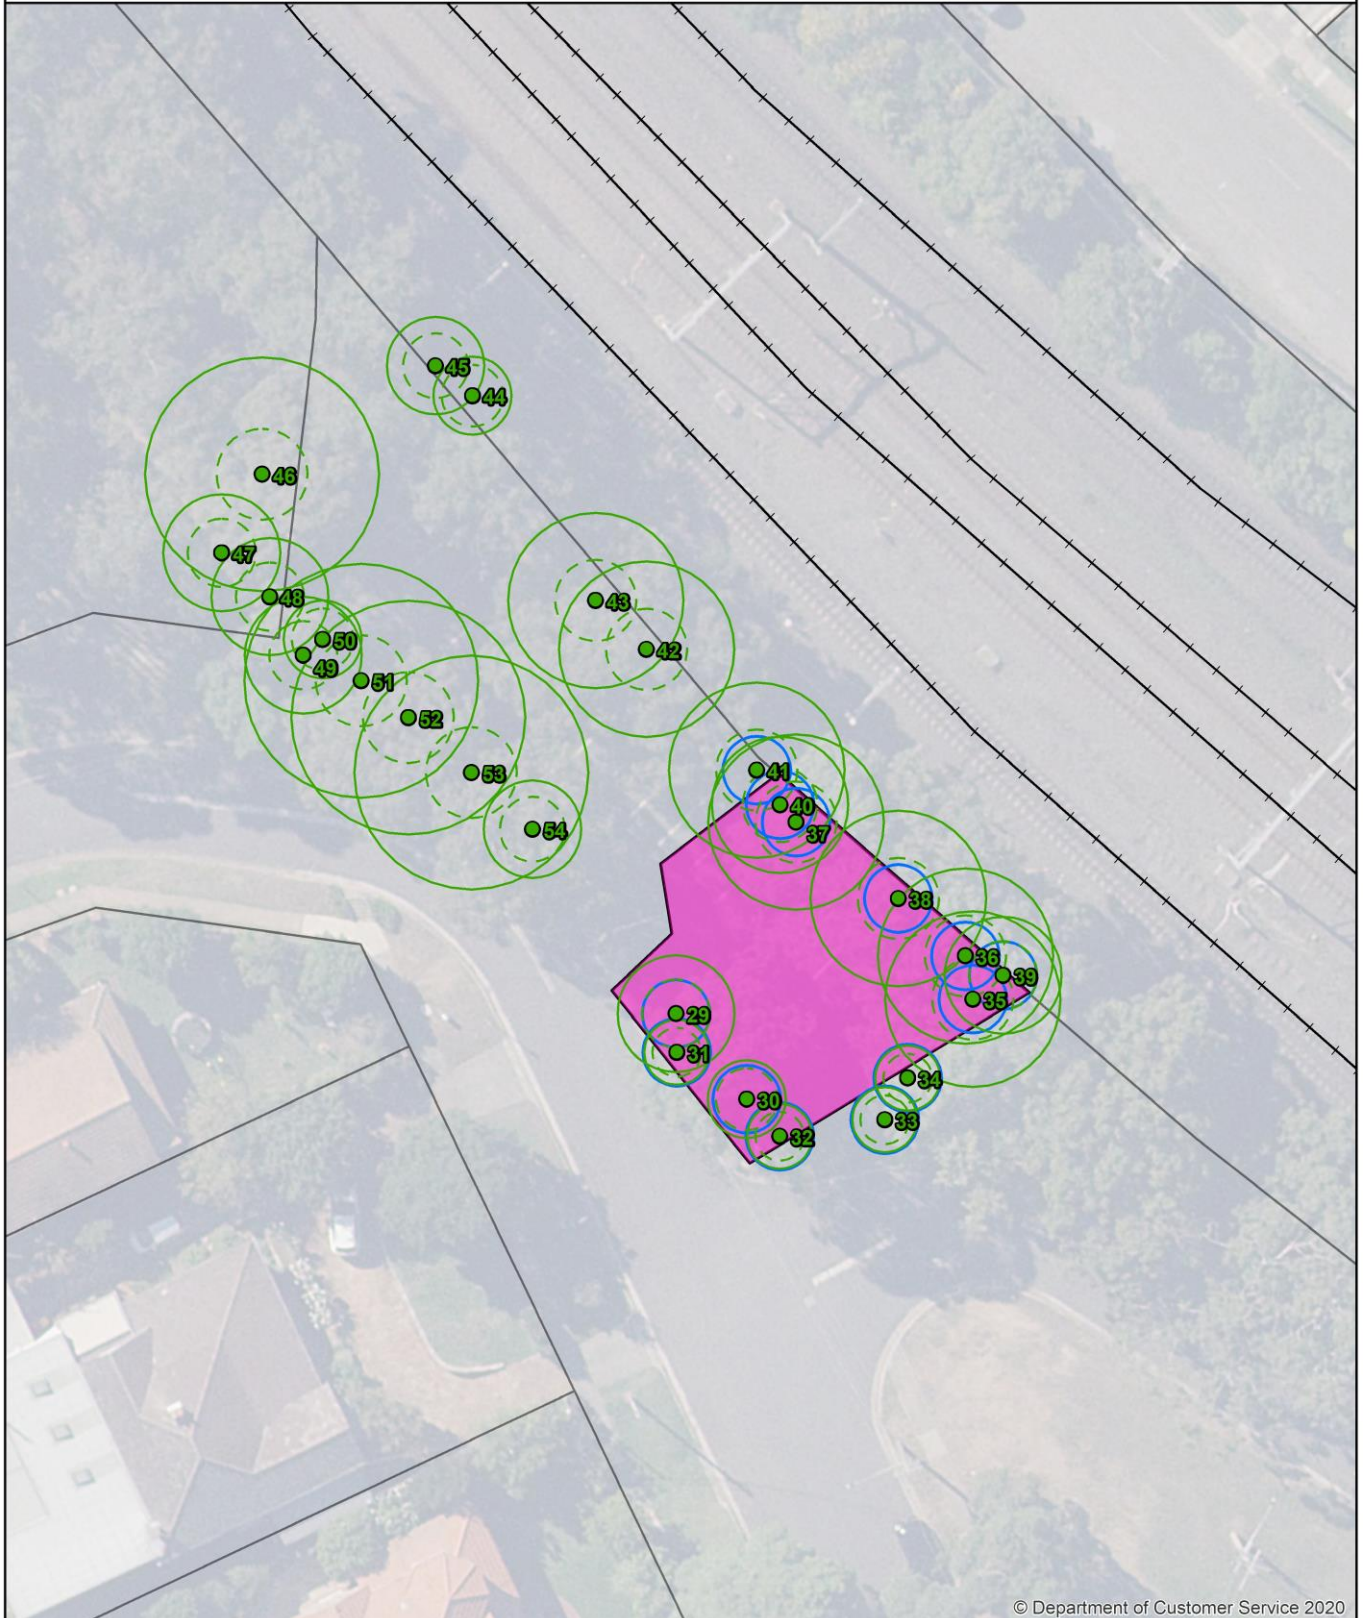
Tree protection fencing must be established at the locations shown in the tree protection plan (see Plans below referenced Pages 1 to 4). Existing fencing, site hoarding, or structures (such as a wall or building) may be used as tree protection fencing, providing the TPZ remains isolated from the construction footprint. Tree protection fencing must be installed prior to site establishment and remain intact until the completion of works. Once erected, protective fencing must not be removed or altered without the approval of the project arborist. Specifications for the tree protection fencing are as follows:

Trunk protection fencing must be installed on **Tree 1, 4, 22, 23, 24, 28, 29, 30, 31, 32, 33, 34, 35, 36, 37, 38, 39, 40, 41.**

Trunk protection fencing must be established at the locations shown in the tree protection plan. If temporary access for vehicle, plant, or machinery is required within the TPZ ground protection shall be installed. The purpose of ground protection is to prevent root damage and soil compaction within the TPZ. Where possible, areas of the existing pavement shall be used as ground protection.
