# Oxley Highway to Kempsey

2018-19 Annual Ecological Monitoring Report

Roads and Maritime Services | September 2019

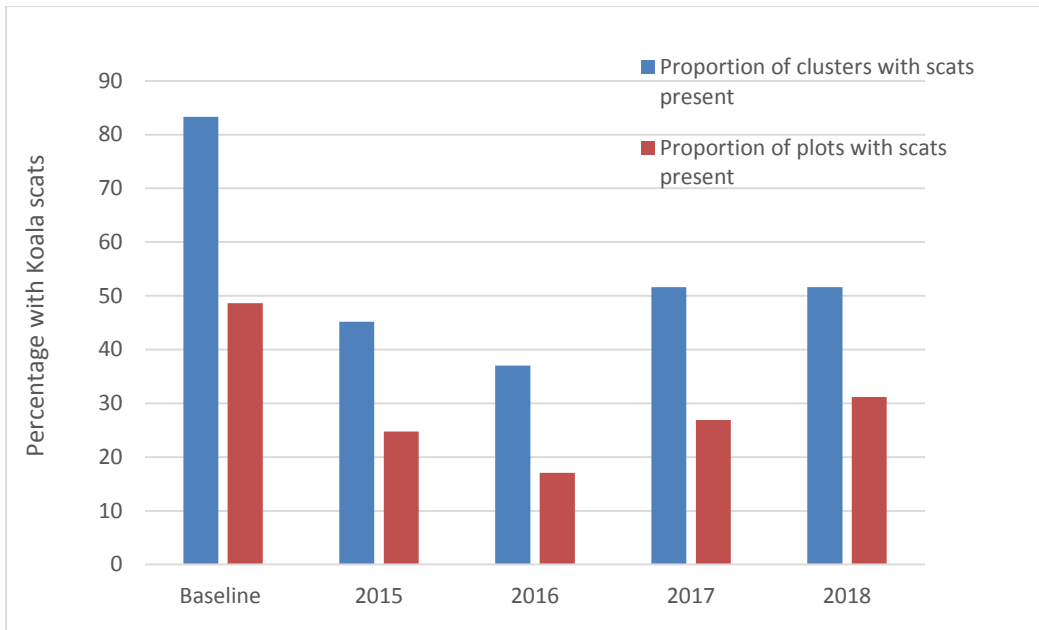
**Graph 1: Percentage of plots and clusters with scats present for each monitoring event to date**

Of the 93 surveyed plots, Koala scats were recorded from 31% (29 of 93) of the individual plots. This is higher than 2015, 2016 and 2017 surveys (25%, 17%, and 27% respectively), but lower than the 49% recorded during baseline surveys. When grouped according to cluster, Koala scats were recorded at 52% of clusters (16 of 31). This is the same as recorded in 2017, higher than recorded in 2015 and 2016 (45% and 37% respectively), but lower than the 83% recorded during baseline surveys. It should be noted that baseline surveys included only 24 (of 31) clusters; if we consider only those clusters in common between baseline and 2018 surveys, scats were recorded at 57% (13 of 23) of these clusters during the 2018 monitoring.

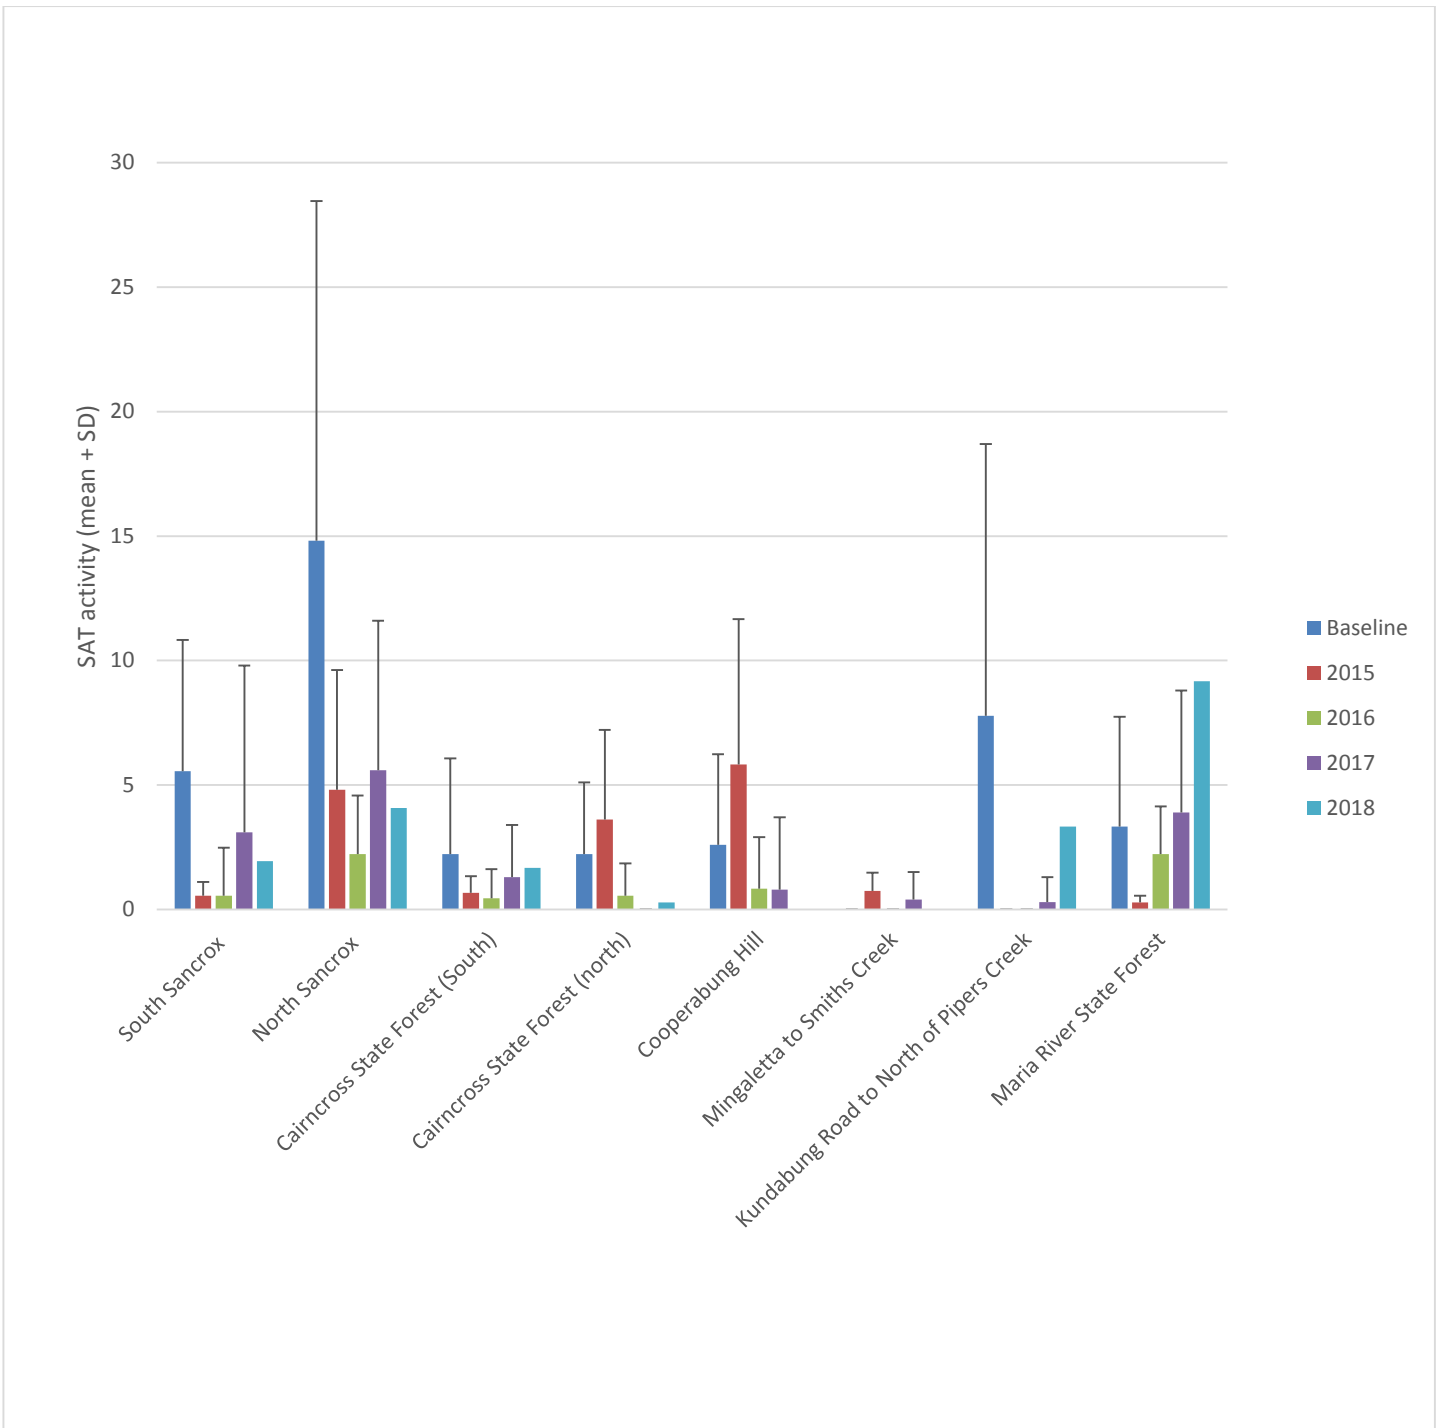
Graph 3: Koala activity across the eight monitoring areas

Monitoring Area	Baseline	2015	2016	2017	2018
South Sancrox	5.6% (SD5.3)	0.6% (SD1.3)	0.6% (SD1.9)	3.1% (SD6.7)	1.9% (SD3.0)
North Sancrox	14.8 (SD13.7)	4.8% (SD5.0)	2.2% (SD2.4)	5.6% (SD6.0)	4.1% (SD3.2)
Cairncross State Forest (South)	2.2% (SD3.8)	0.7% (SD1.9)	0.4% (SD1.2)	1.3% (SD2.1)	1.7% (SD2.7)
Cairncross State Forest (North)	2.2% (SD2.9)	3.6% (SD5.9)	0.6% (SD1.3)	0	0.3% (SD1.0)
Cooperabung Hill	2.6% (SD3.6)	5.8% (SD8.8)	0.8% (SD2.1)	0.8% (SD2.9)	0
Mingaletta to Smiths Creek	0	0.7% (SD2.2)	0	0.4% (SD1.1)	0
Kundabung Road to North of Pipers Creek	7.8% (SD10.9)	0	0	0.3% (SD1.0)	3.3% (SD5.9)
Maria River State Forest	3.3% (SD4.4)	0.3% (SD1.0)	2.2% (SD1.9)	3.9% (SD4.9)	9.2% (SD10.6)

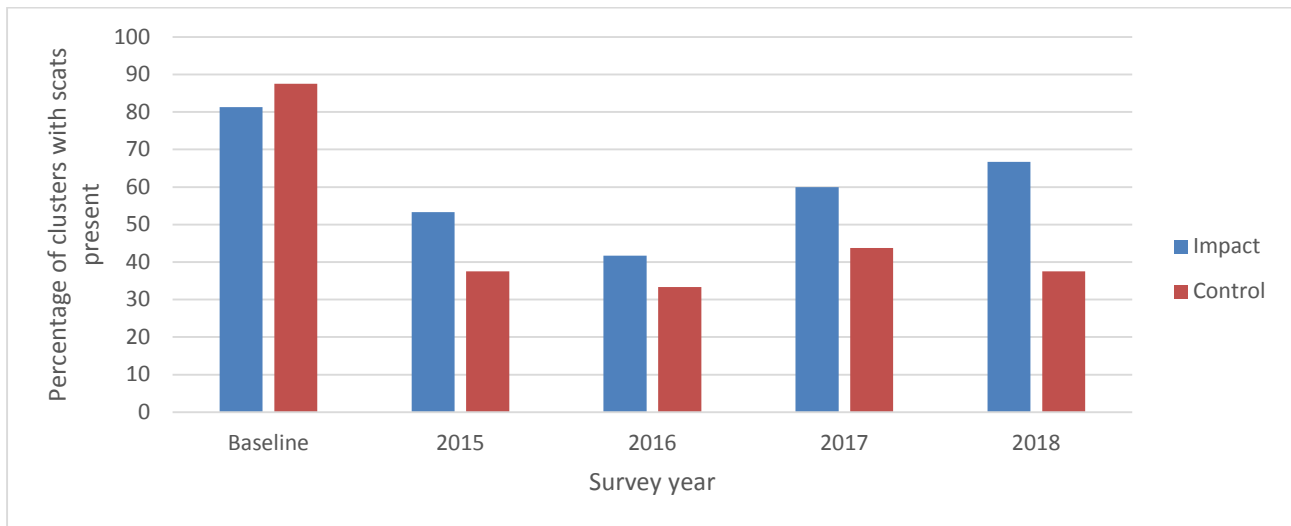
Graph 4: Koala presence at control and impact clusters

A higher percentage of impact clusters had scats present than did control clusters during the 2018 monitoring (67% cf 38%) period. This result is the same as that of the previous monitoring years (Graph 4). If we compare the Koala presence/absence results between control and impact clusters there is no significant difference in Koala presence at impact and control clusters between the 2018 surveys and baseline, 2015, 2016 or 2017 surveys ( $X^2 = 0.012$ ,  $df = 1$ ,  $p > 0.05$ ;  $X^2 = 0.425$ ,  $df = 1$ ,  $p > 0.05$ ;  $X^2 = 0.291$ ,  $df = 1$ ,  $p > 0.05$ ; and  $X^2 = 0.365$ ,  $df = 1$ ,  $p > 0.05$  respectively).

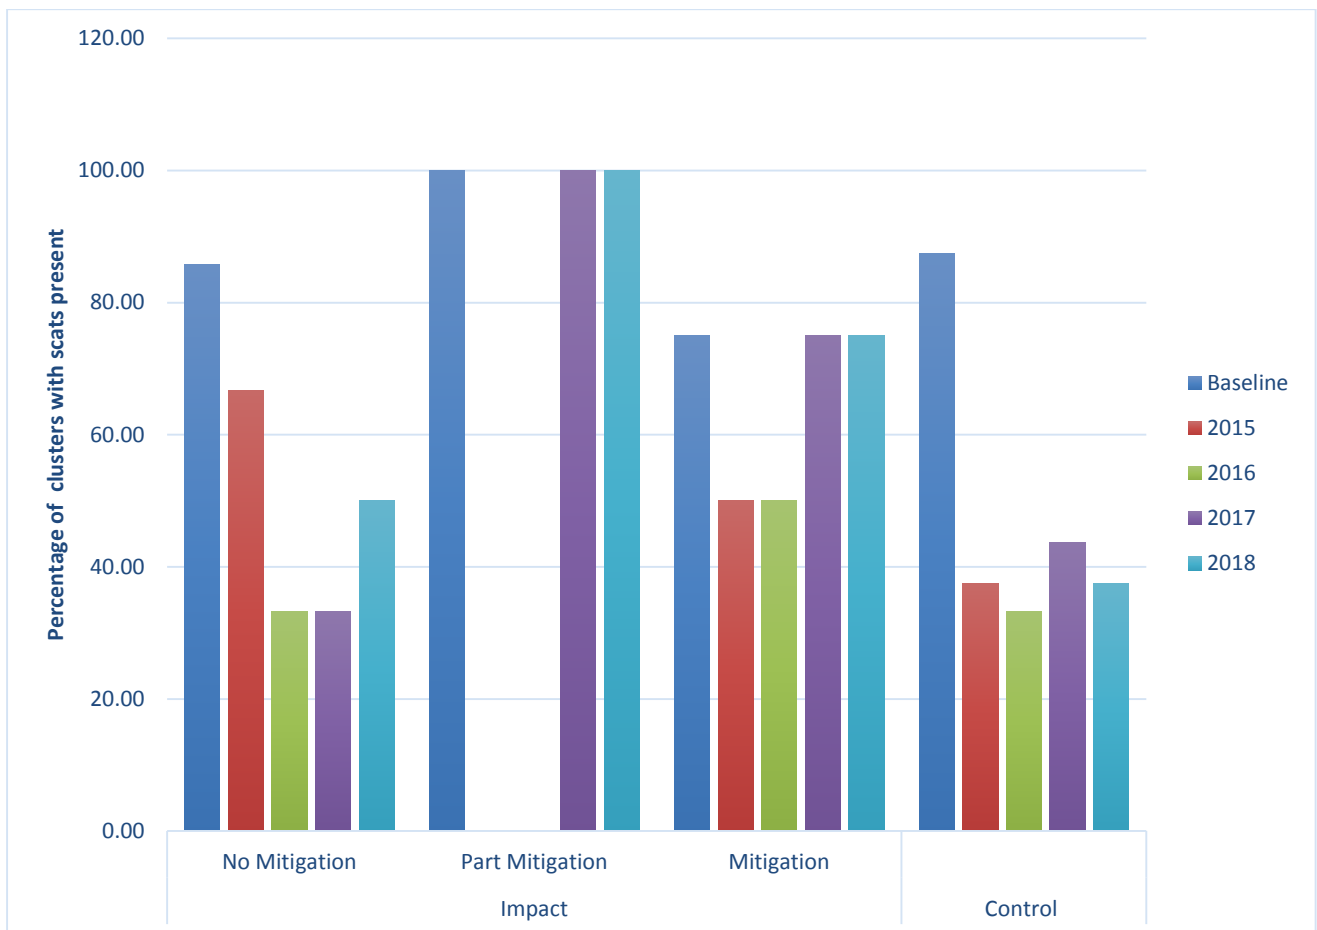
Graph 5: Koala presence and cluster type

The apparent increase in percentage presence in 2017 and 2018 at mitigation (and part mitigation) clusters is likely due, in part, to the 11 plots that were not surveyed in 2016. Five of these plots are mitigation plots, four of which recorded scats in 2018. In addition, North Sancrox has consistently been recorded as a high activity area and has only a mitigation cluster, without a balancing no-mitigation cluster.

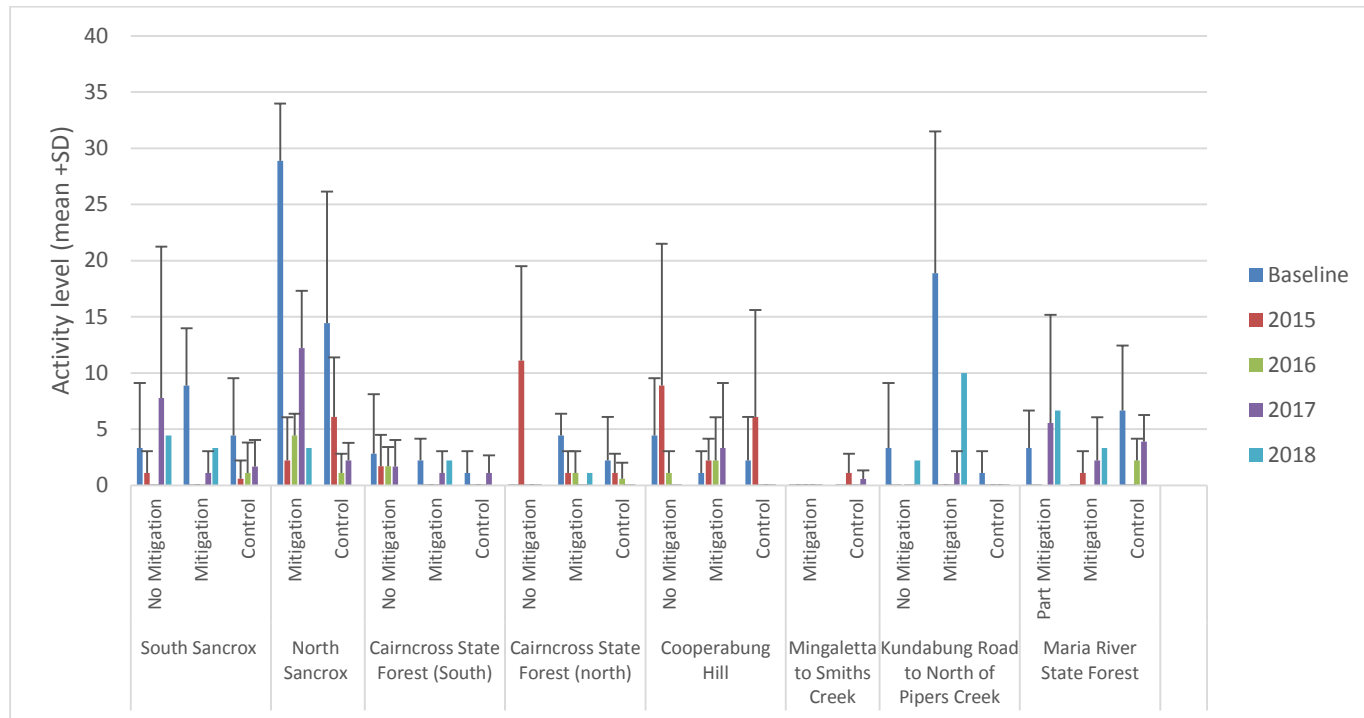
**Graph 6. Mean Koala activity for cluster type within areas (mean ± SD)**

When considering all plots or active plots only, activity levels for each treatment type have not decreased from the baseline surveys beyond the recommended 10% tolerance level. Nor is there a greater than 10% difference between treatment types.

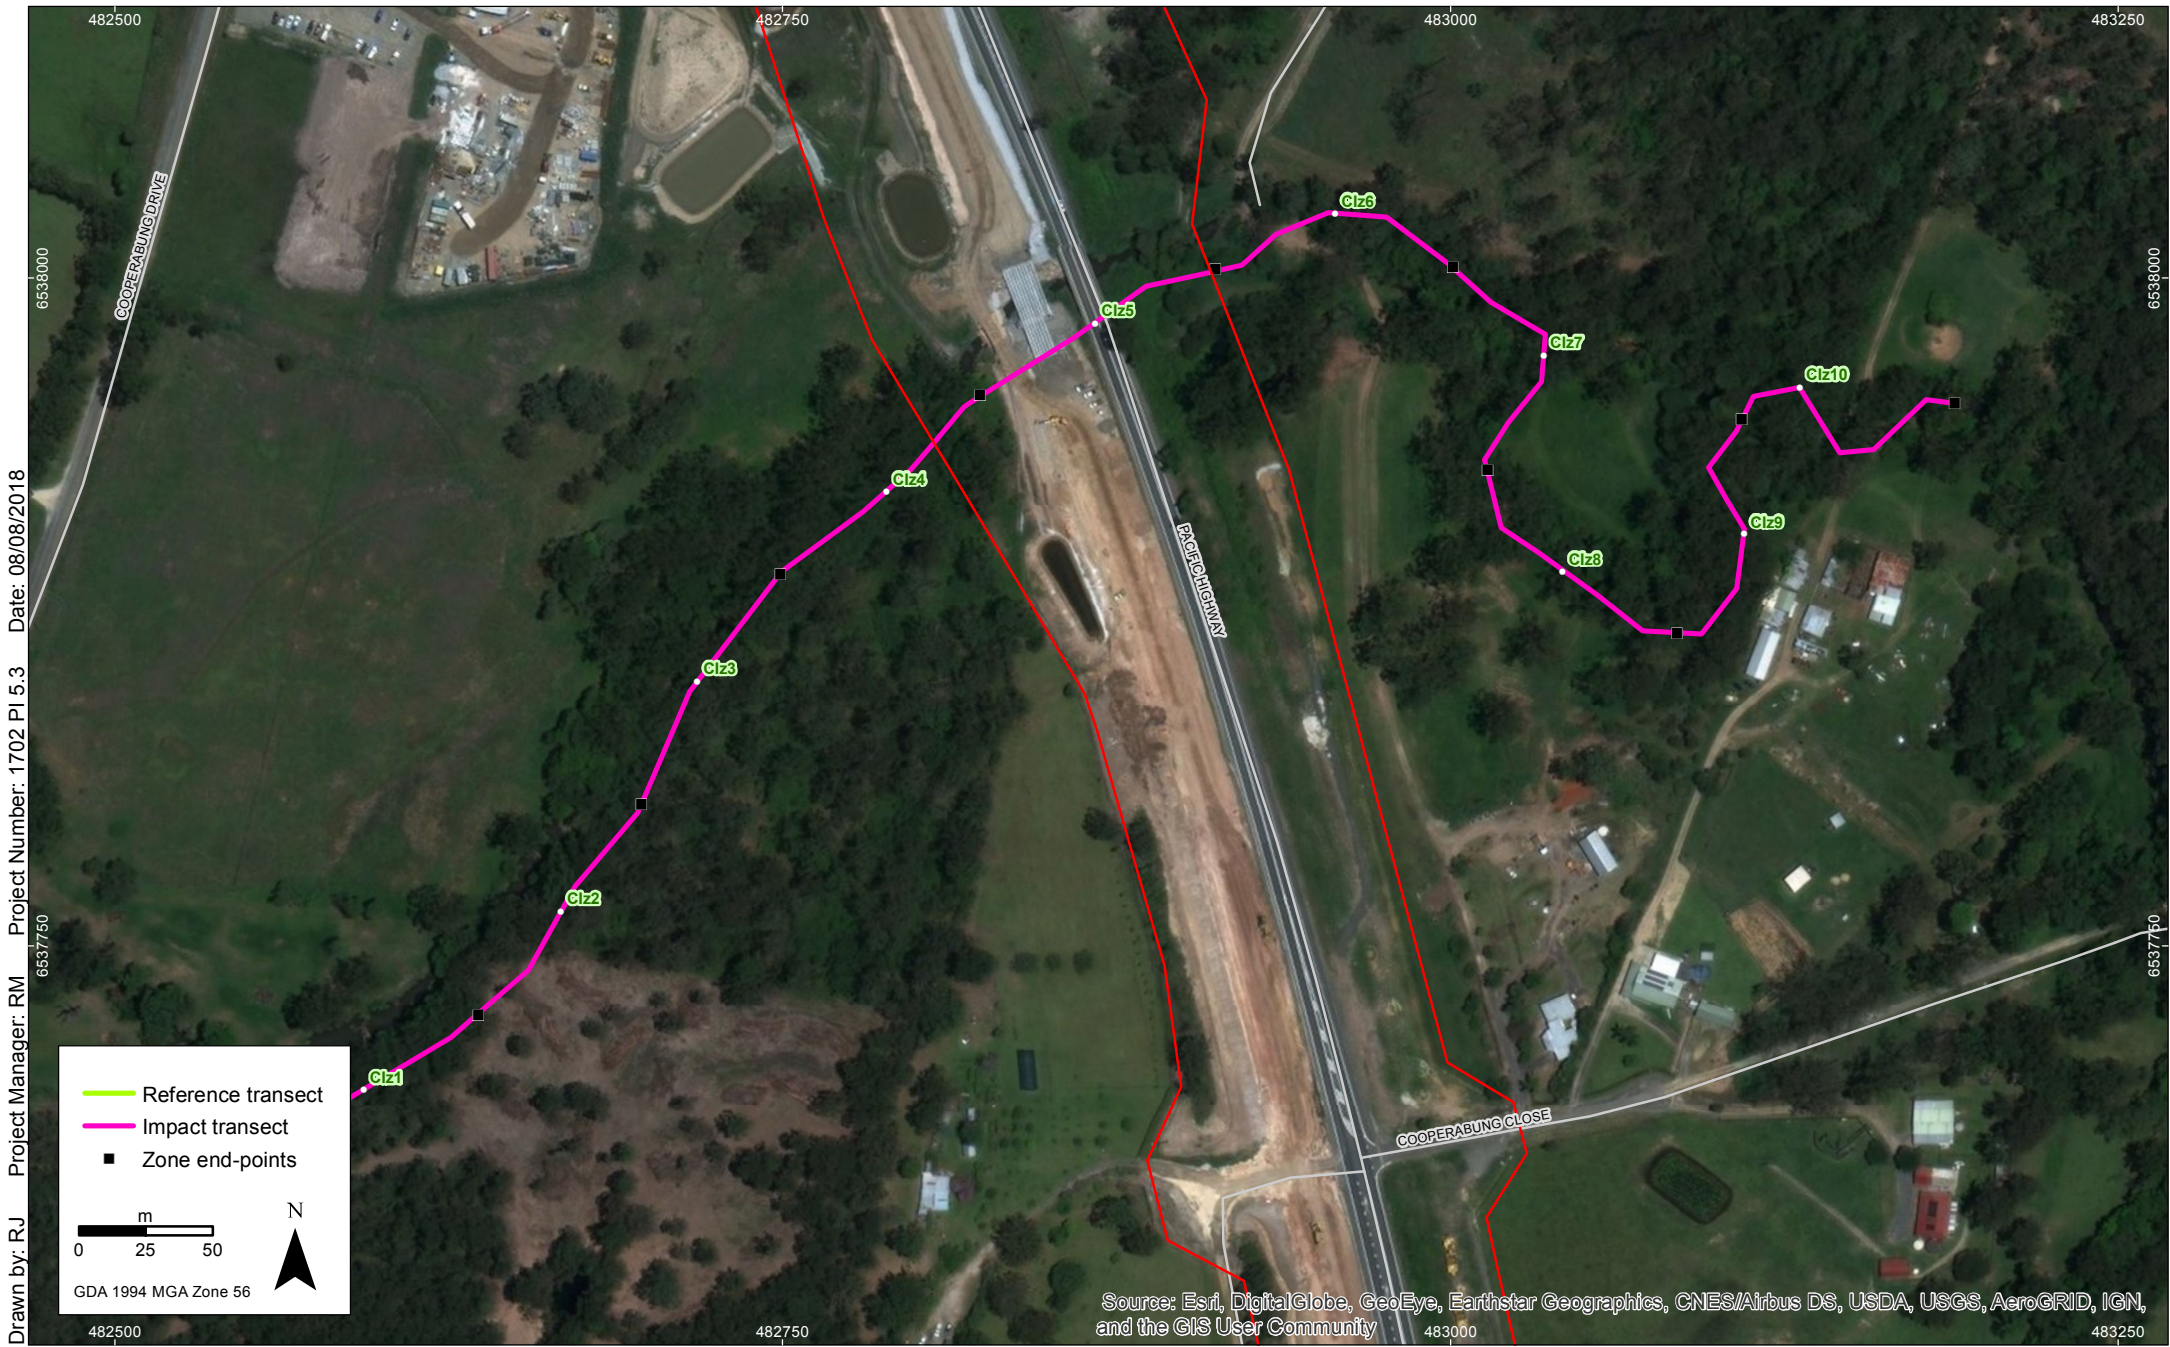
Giant Barred Frog monitoring: Cooperabung Creek impact site  
 Pacific Highway Upgrade - Oxley Highway to Kempsey

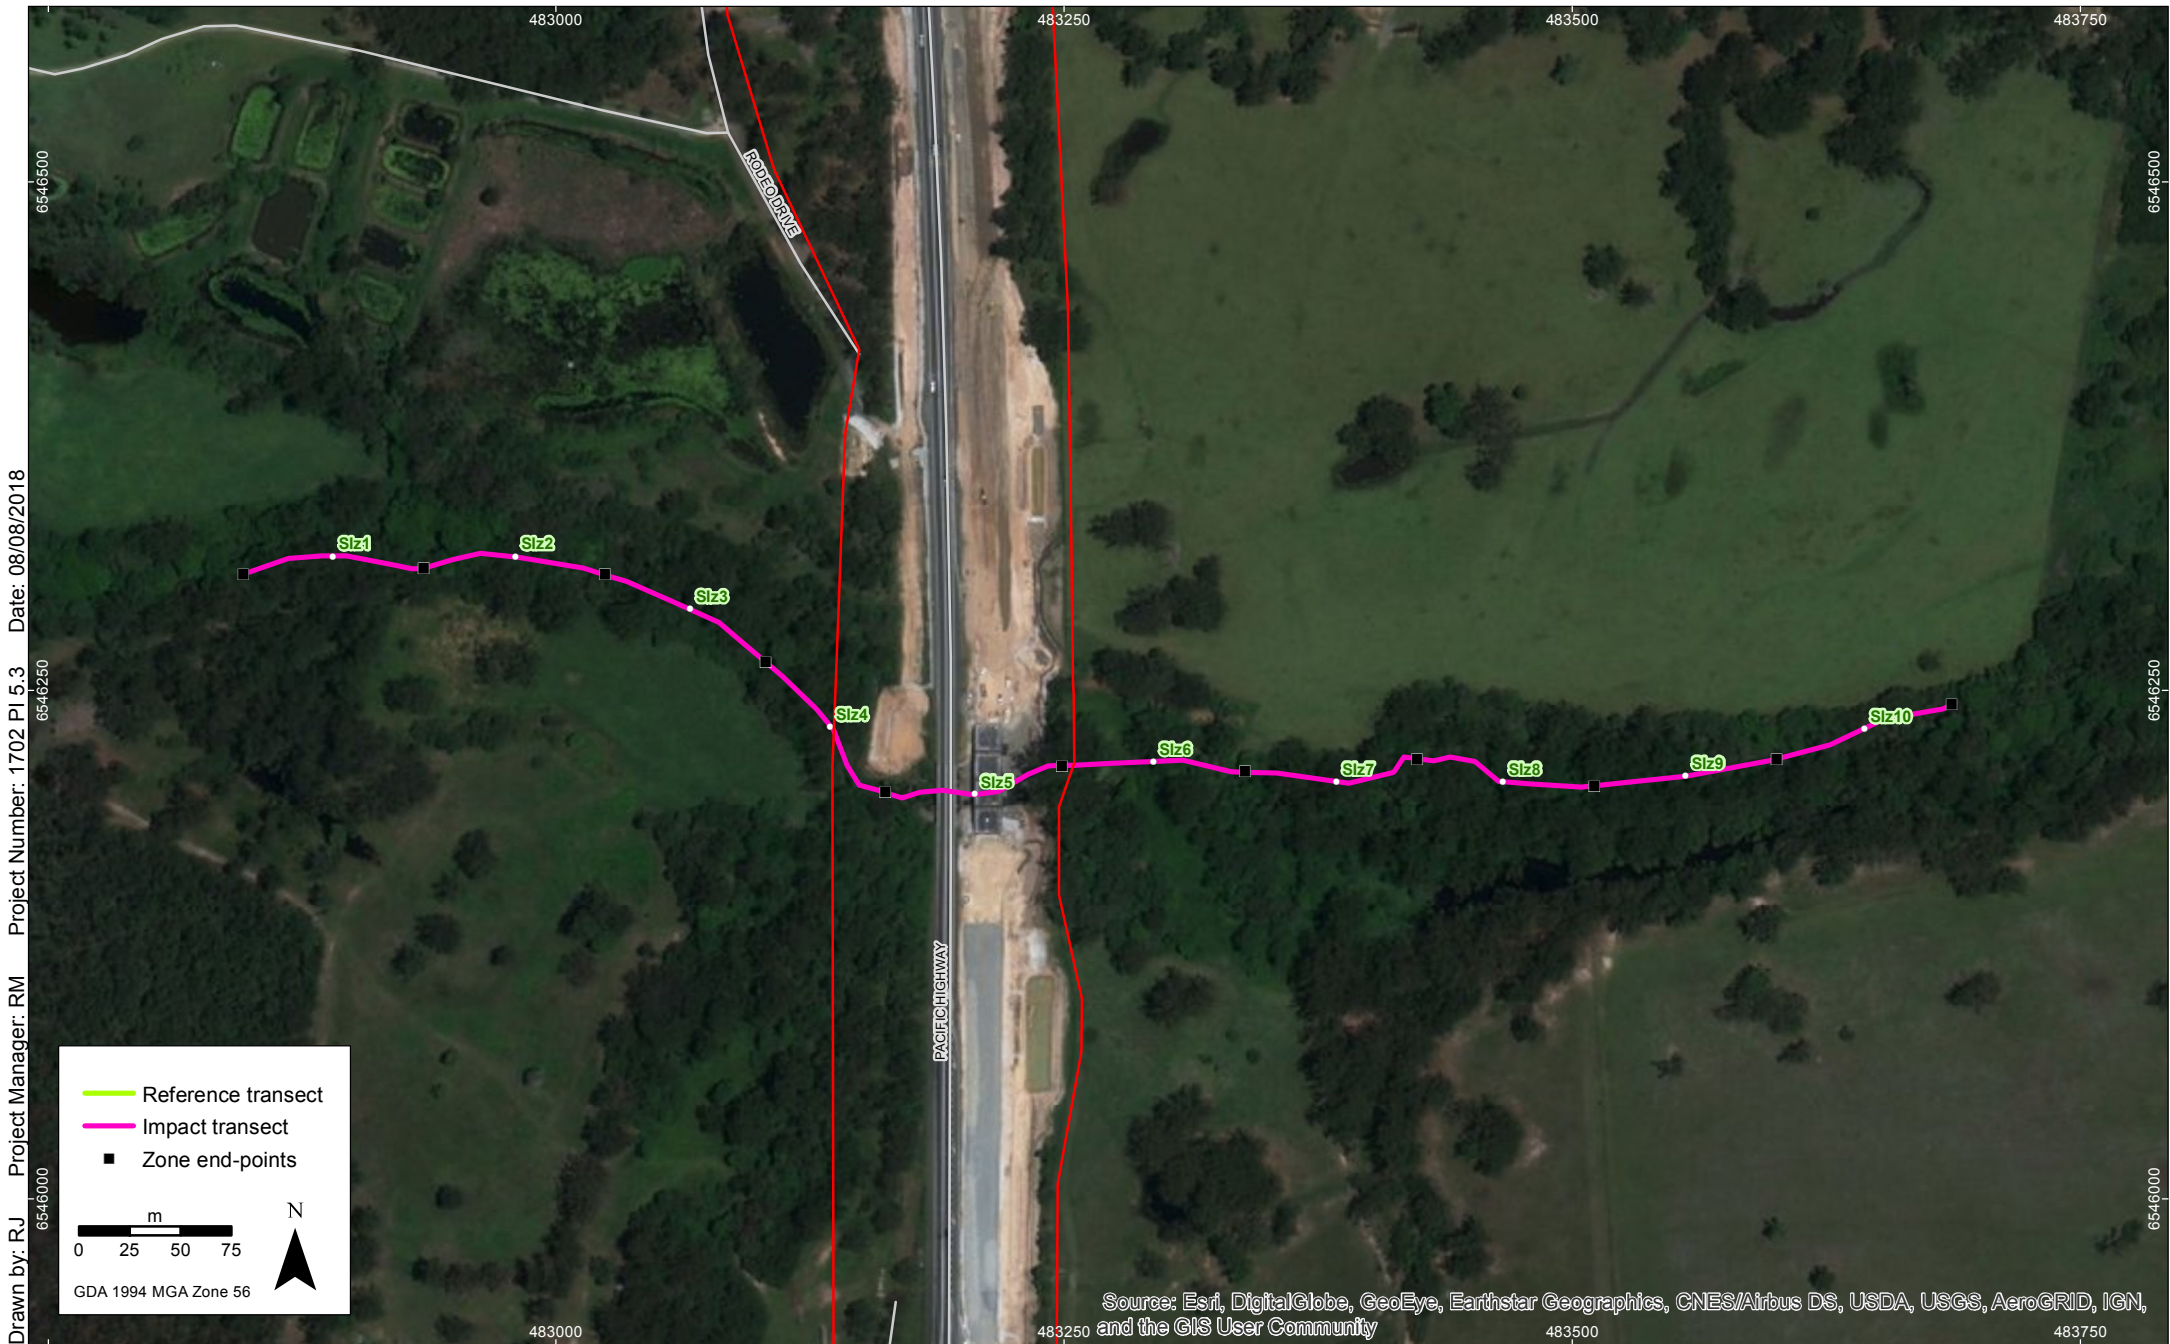
**FIGURE 3**

Giant Barred Frog monitoring: Smiths Creek impact site  
Pacific Highway Upgrade - Oxley Highway to Kempsey

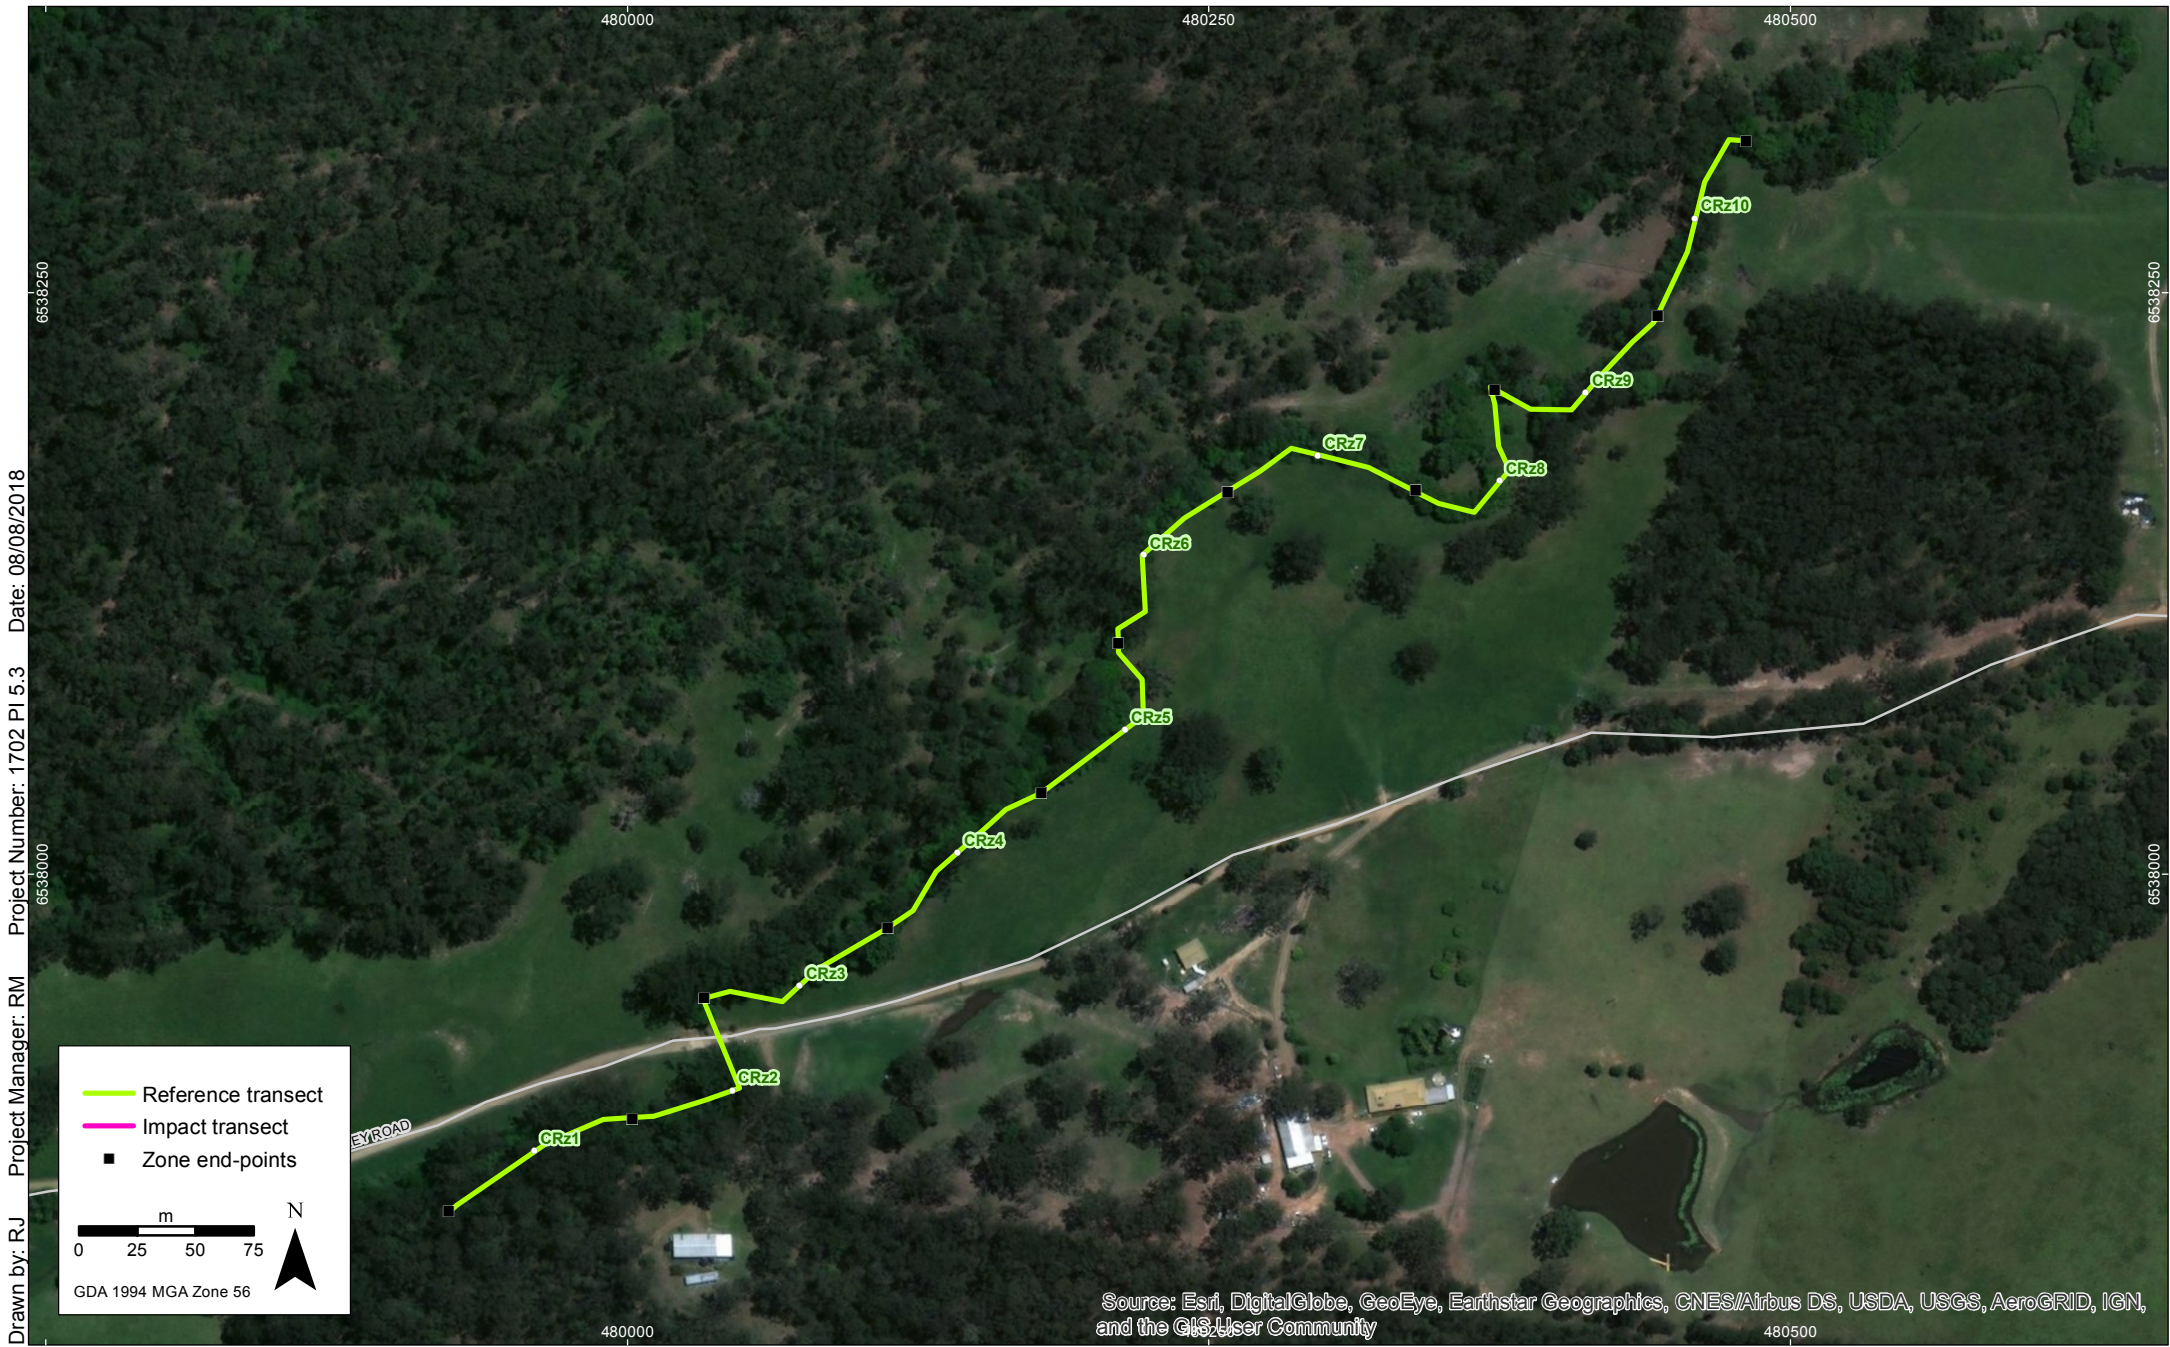
Giant Barred Frog monitoring: Cooperabung Creek reference site  
 Pacific Highway Upgrade - Oxley Highway to Kempsey

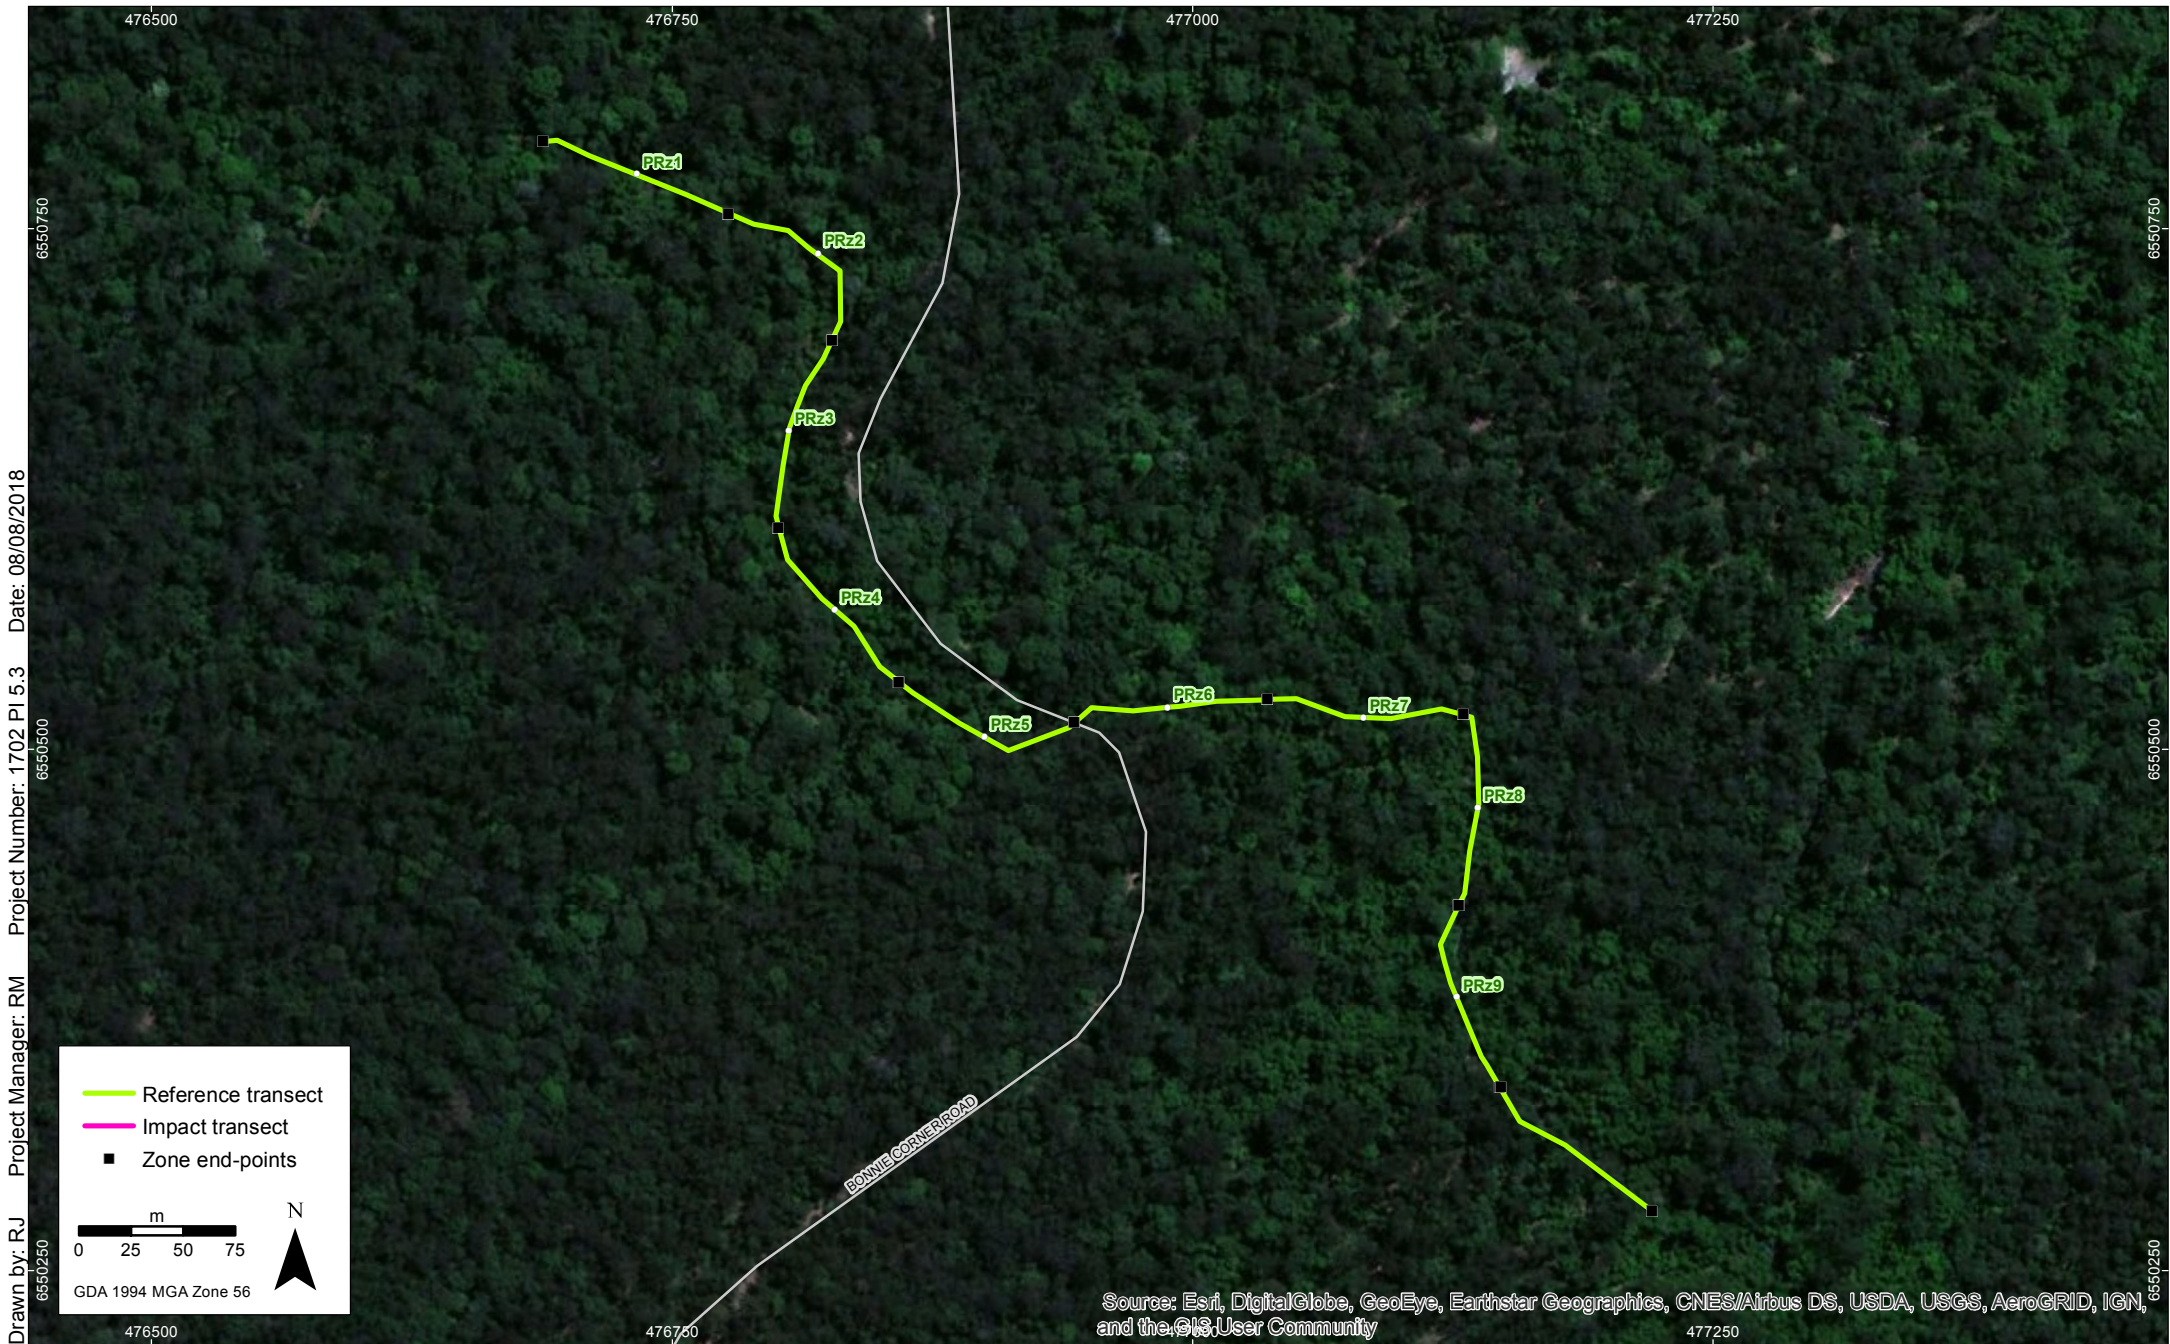
Giant Barred Frog monitoring: Pipers Creek reference site  
Pacific Highway Upgrade - Oxley Highway to Kempsey

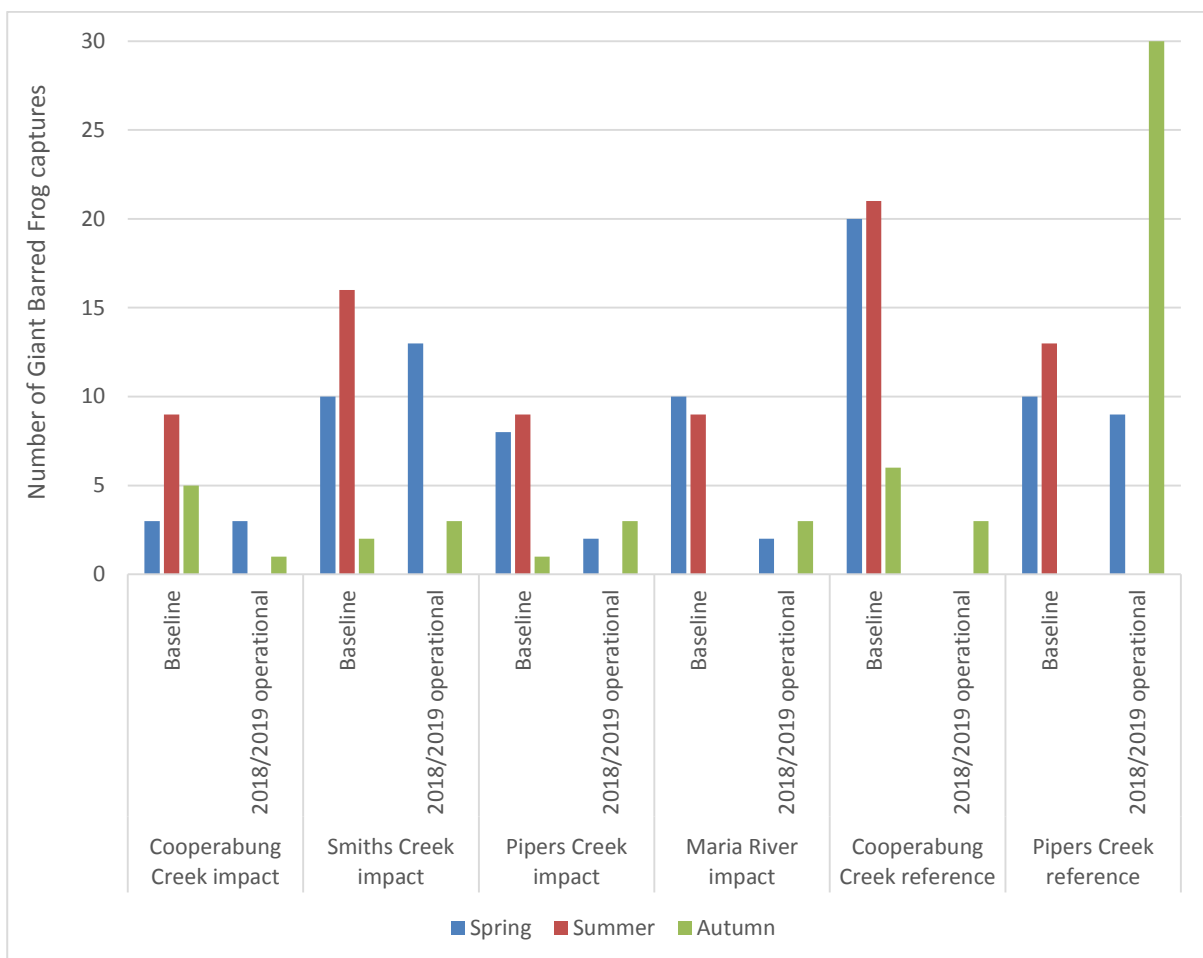
**Graph 1: Giant Barred Frog records: baseline and 2018/2019 monitoring**

Giant Barred Frogs were therefore recorded during all 2018/2019 surveys at the two sites (one impact site) where they were not recorded during the autumn baseline surveys (Pipers Creek reference site and Maria River impact site), however they were not recorded at the Cooperabung Creek reference site in the spring survey, where they were recorded during baseline surveys.

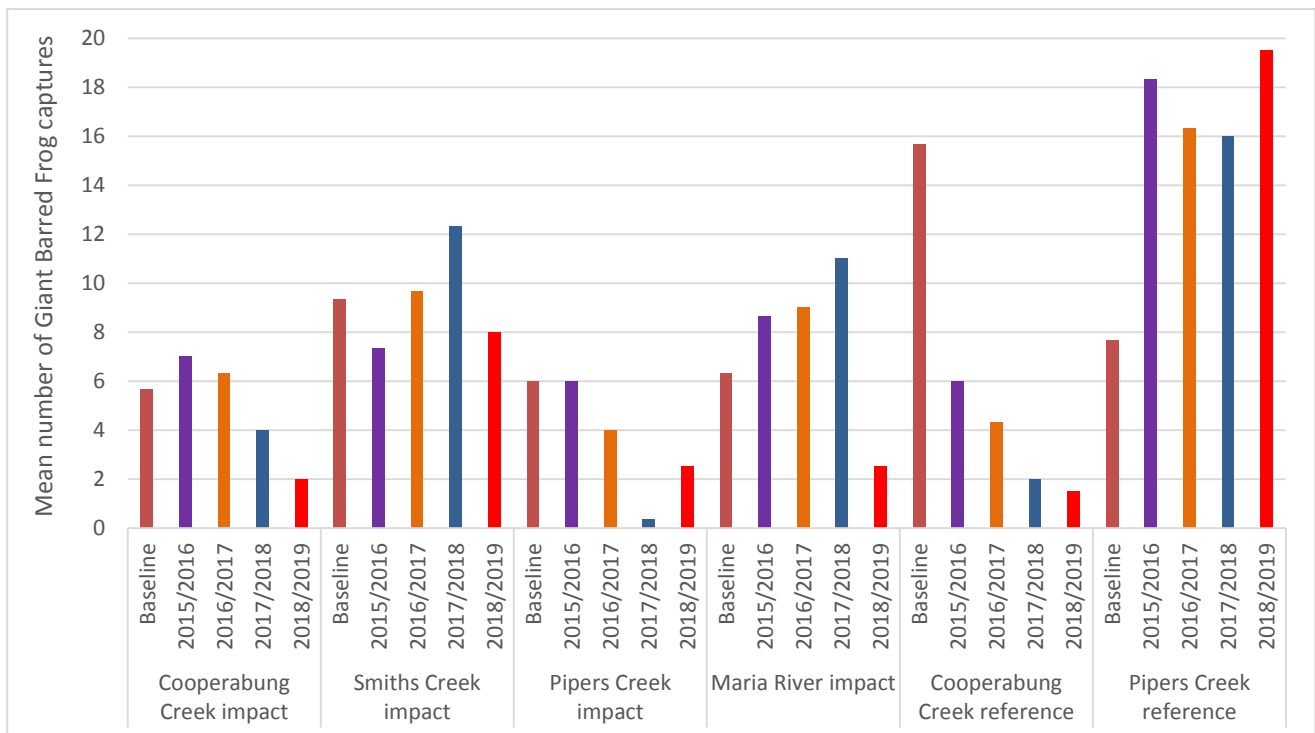
**Graph 2: Mean annual Giant Barred Frog records by site**

Given the variable nature of annual mean records among sites, the absence of summer survey records from the current monitoring period, the evidence of a decreasing trend at a reference site and the lack of a distinct difference between impact and reference sites, it is not possible to attribute observed changes to the Project.
