# Oxley Highway to Kempsey

2018-19 Annual Ecological Monitoring Report

Roads and Maritime Services | September 2019

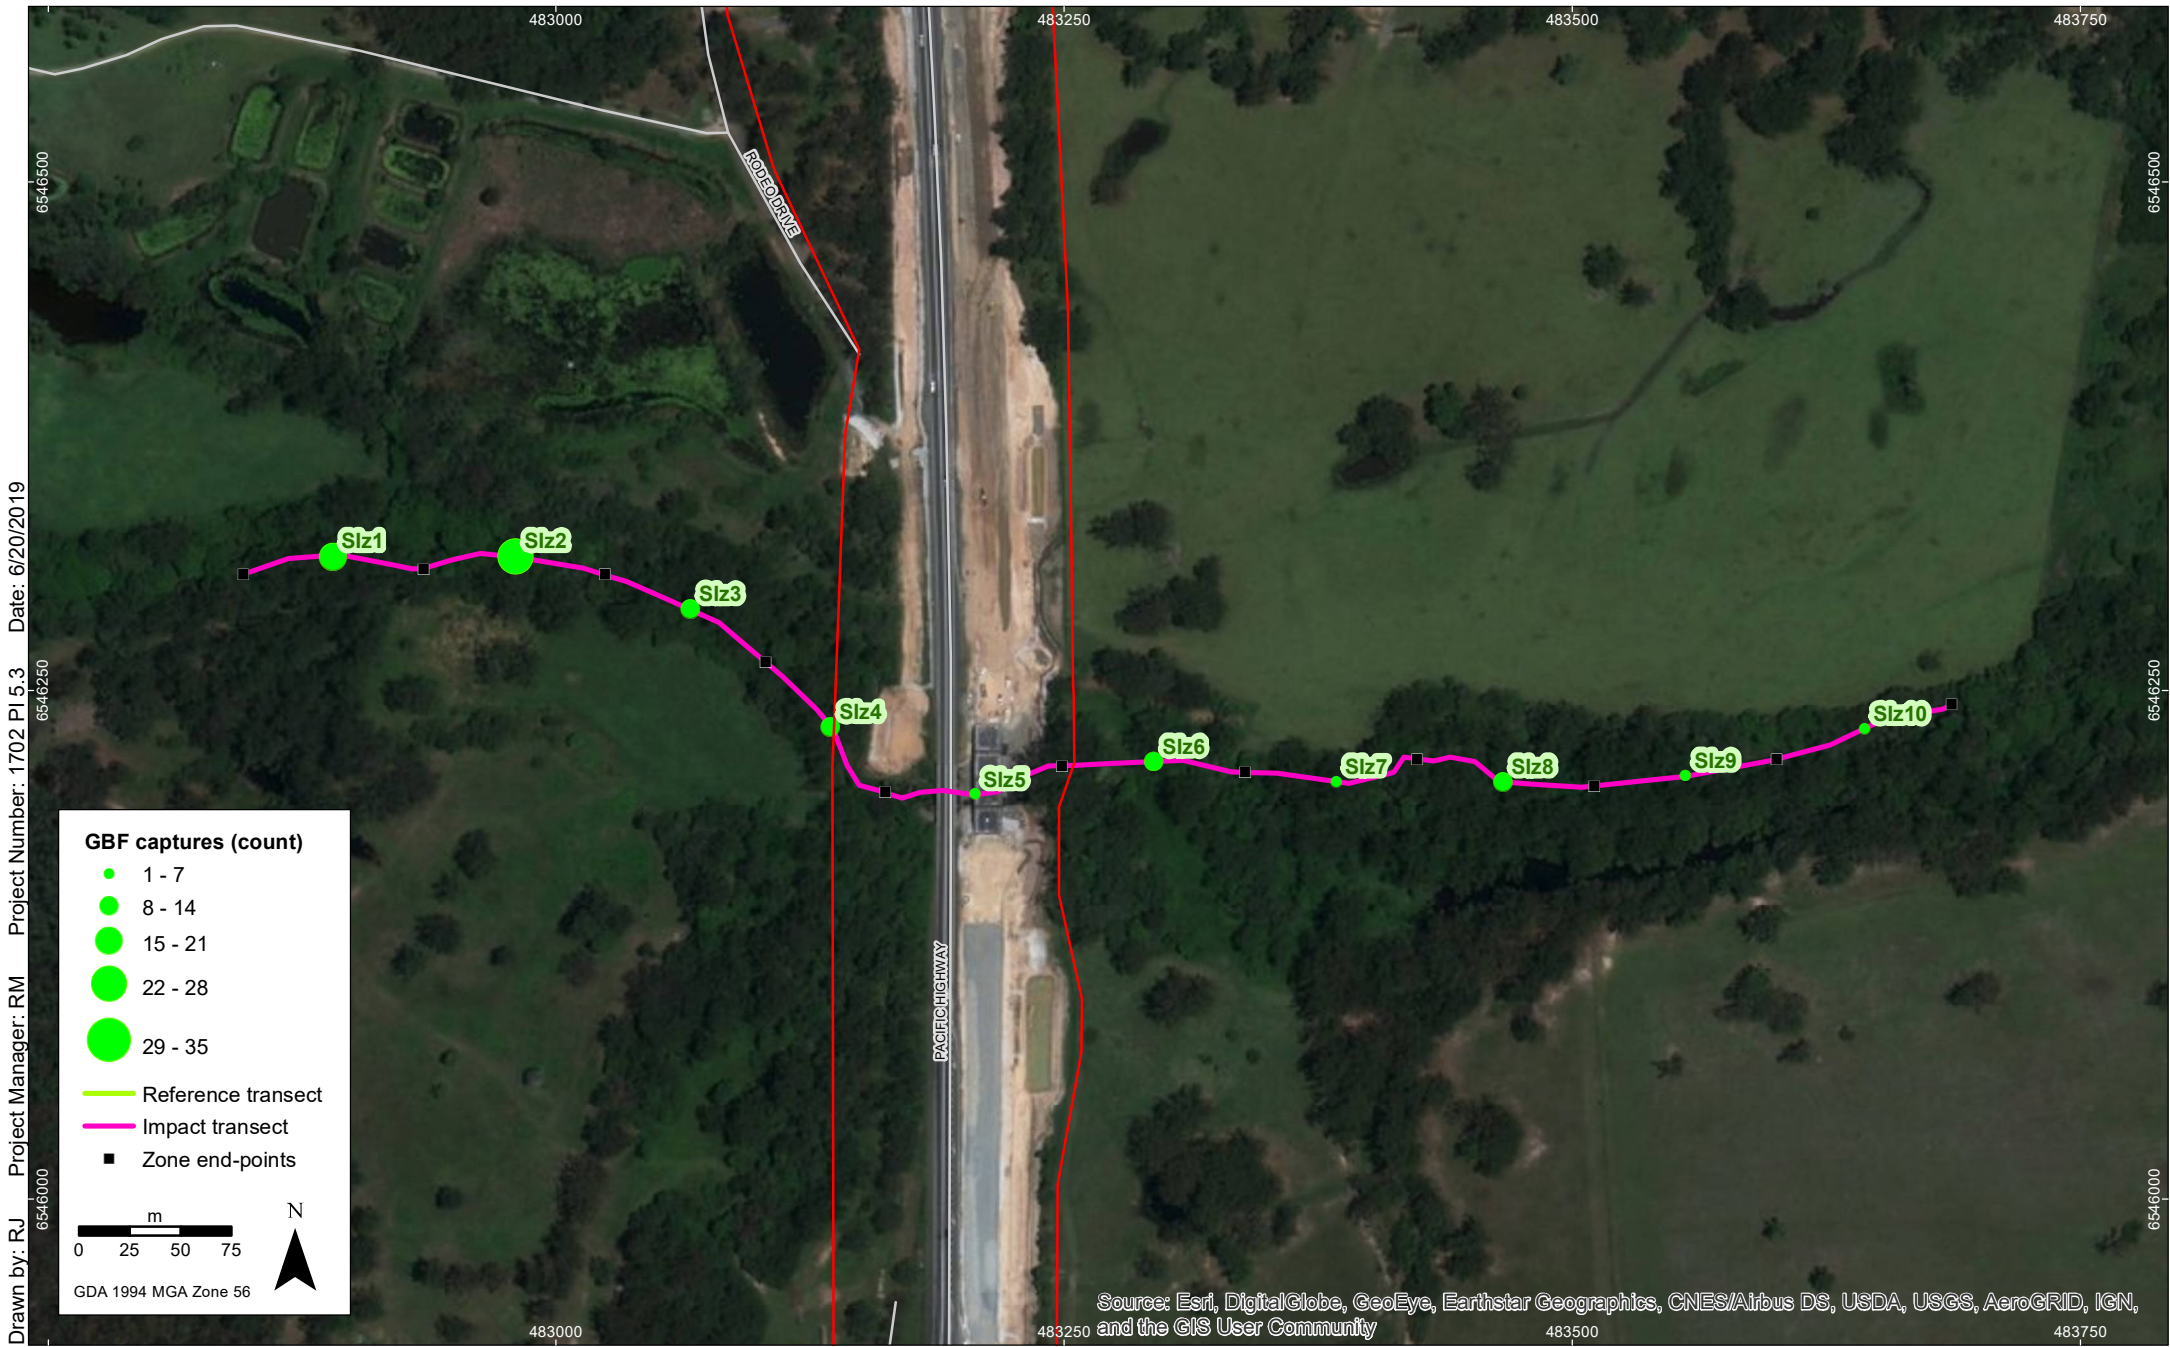
Giant Barred Frog capture distribution: Smiths Creek impact site  
Pacific Highway Upgrade - Oxley Highway to Kempsey

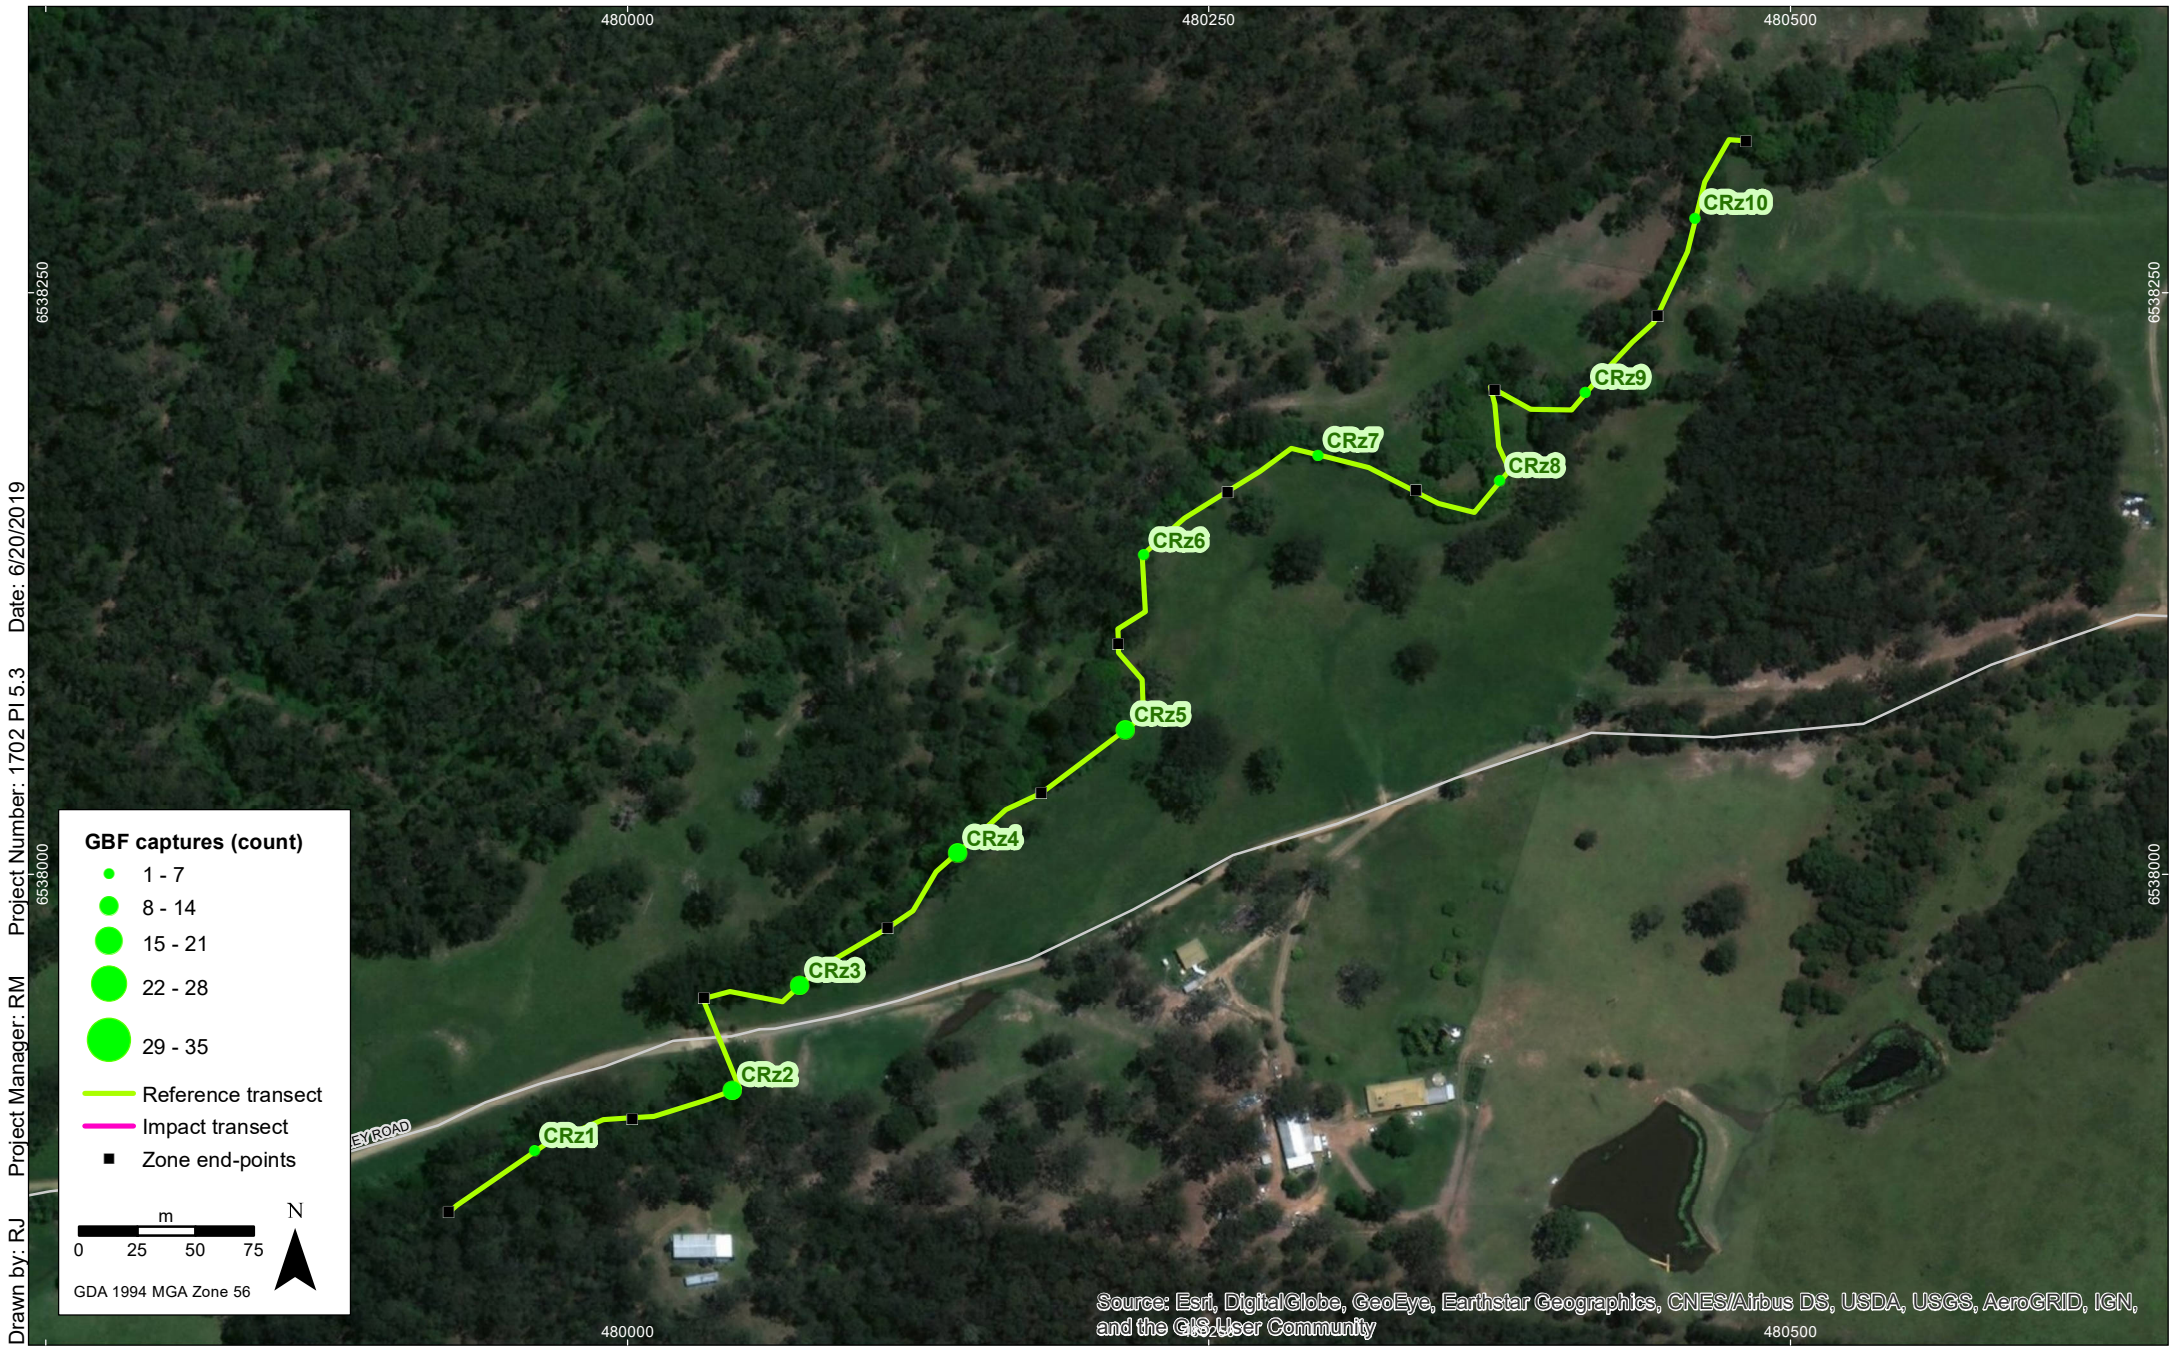
Giant Barred Frog capture distribution: Cooperabung Creek reference site  
Pacific Highway Upgrade - Oxley Highway to Kempsey

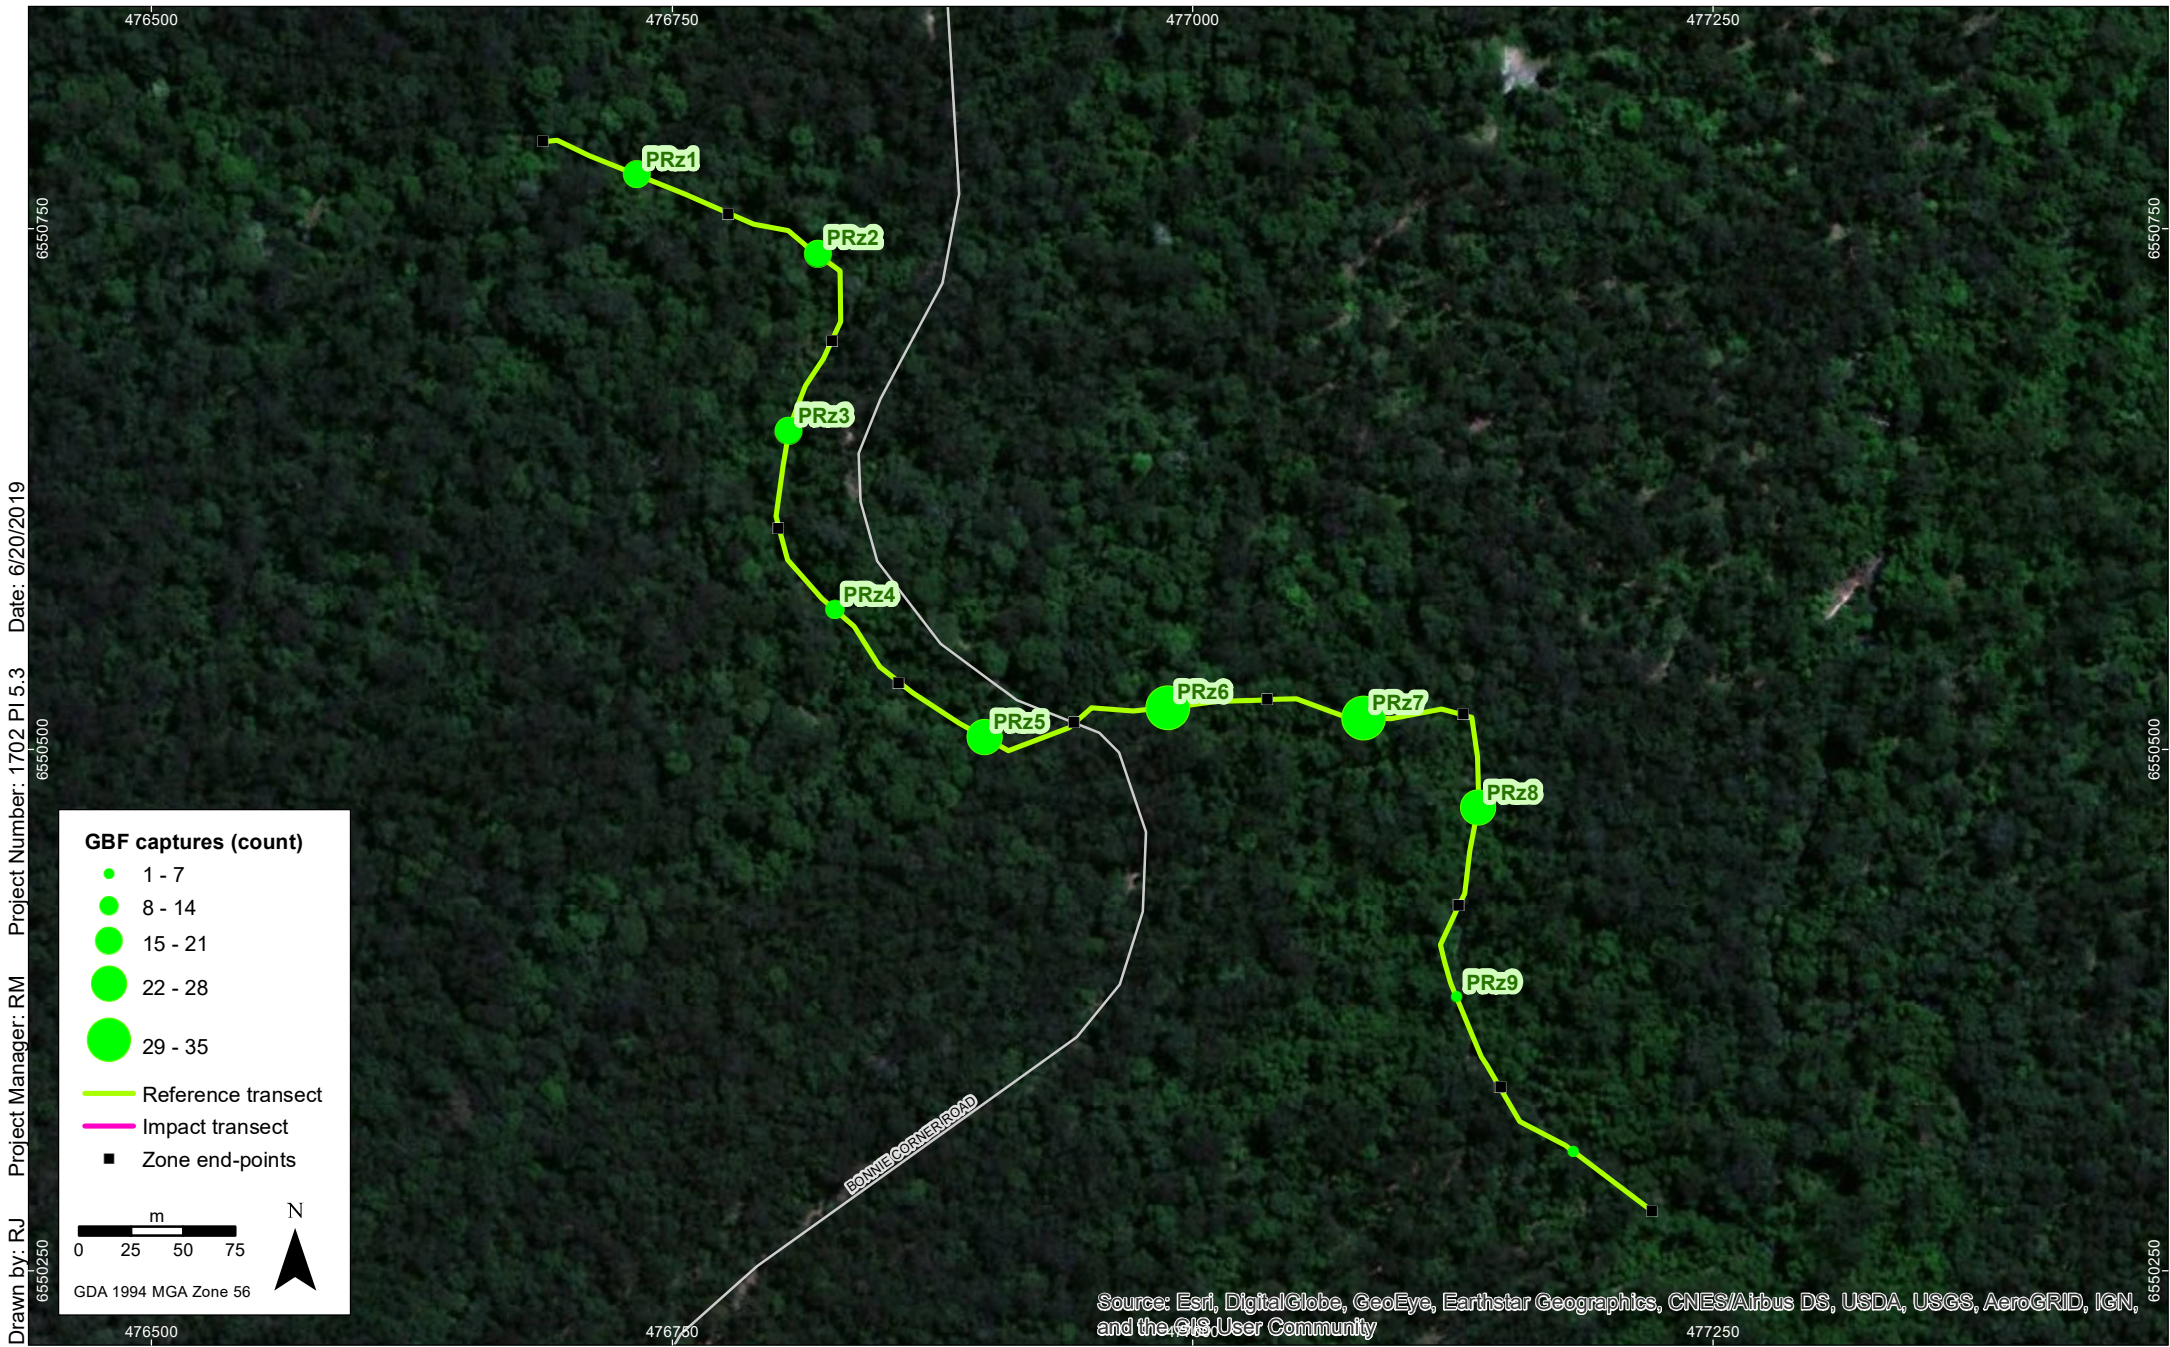
Giant Barred Frog capture distribution: Pipers Creek reference site  
Pacific Highway Upgrade - Oxley Highway to Kempsey

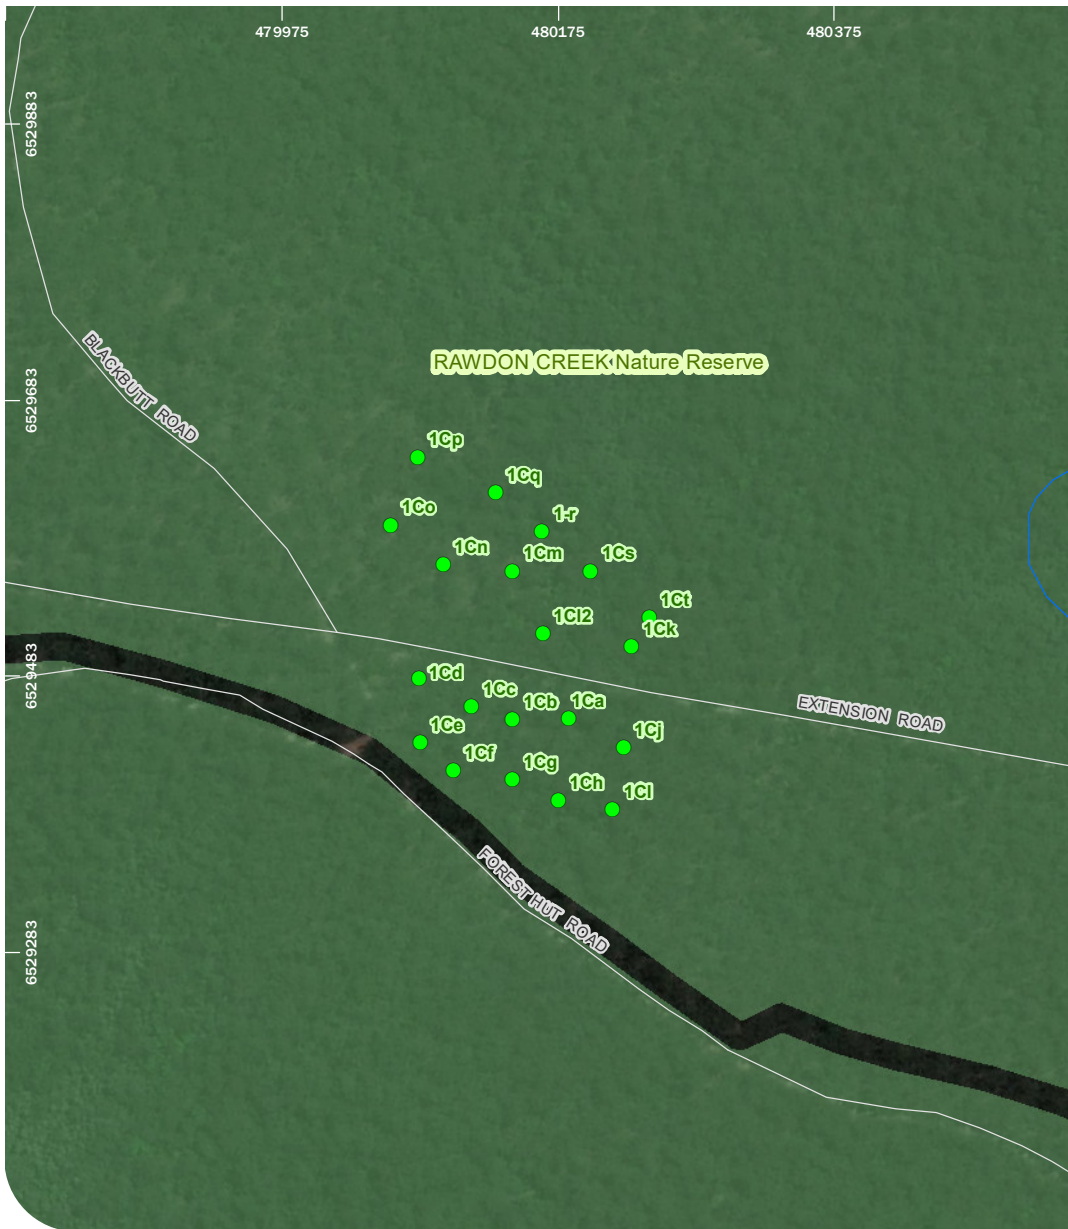
**Figure 1**

### Overview of monitoring sites Brush-tailed Phascogale Monitoring: Pacific Highway Upgrade – Oxley Highway to Kempsey

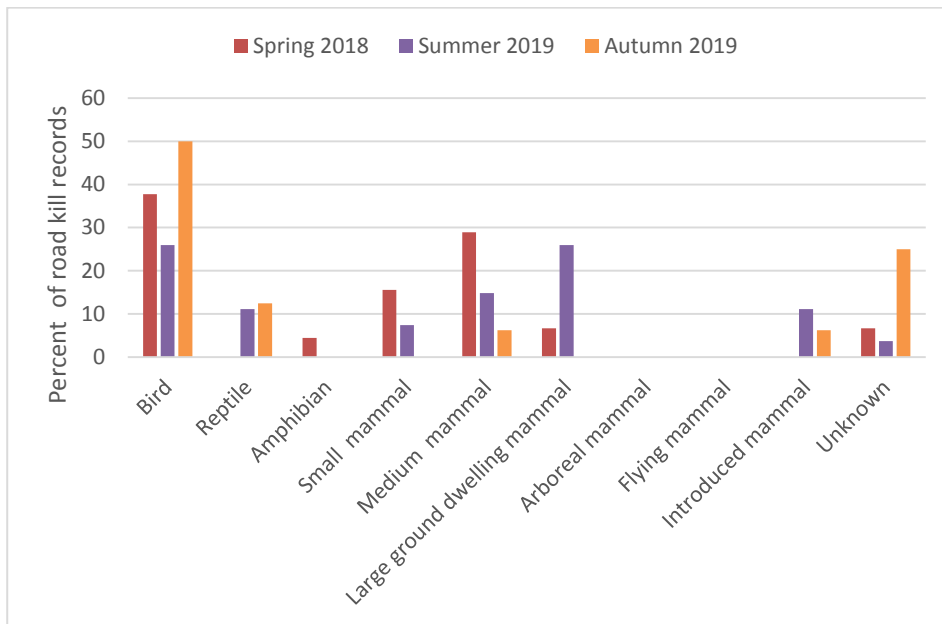
Graph 1: 2018/2019 road kill records

There were a total of 45 road kill records in spring, 27 in summer and 20 in autumn. The percentage of road kill records for each category for the current monitoring period is presented in Graph 1. Combining spring, summer and autumn results, birds (35.9% of road kill, n =33), medium ground dwelling mammals (20.7% of road kill, n = 19), and large ground dwelling mammals (12.0%, n = 11), were the most commonly recorded fauna groups.
