MONITORING OF KOALAS AND OTHER FAUNA
YELGUN TO CHINDERAH SECTION OF PACIFIC MOTORWAY
March 2014 to February 2015

**MONITORING OF FAUNA IN CROSSINGS UNDER THE
YELGUN TO CHINDERAH SECTION OF THE PACIFIC MOTORWAY**

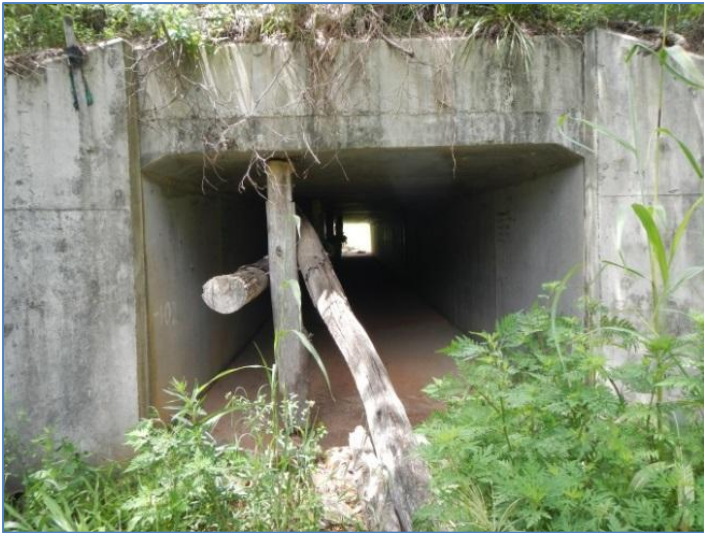
Site one, the culvert south of Eviron Road

The culvert at Eviron Road is functioning as a movement corridor between habitats to the east and west of the motorway. Commonly recorded species such as the Swamp Wallaby and Bandicoots move rapidly through the underpass, presumably as it offers no habitat and minimal refuge from predators. In relation to introduced canid predators, only foxes have been recorded in this underpass although wild dogs are known from the area.

The Eviron culvert is not currently being used by koalas, possibly due to a lack of koala food trees adjacent, or leading up to, the underpass entrances. There is also limited koala habitat on adjacent private land to the east of the underpass. Council has recently received approval from Roads and Maritime Services (RMS) to establish a small koala food tree planting at the eastern fauna underpass entrance and has also commenced planning for additional plantings on the adjoining private land.

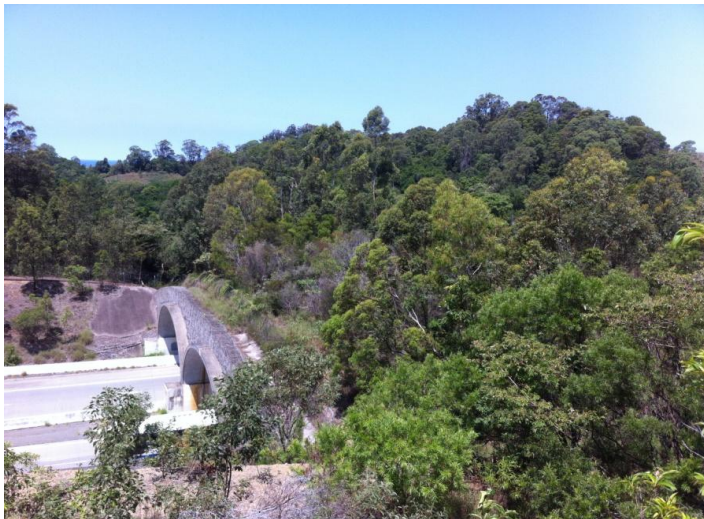
Site five, the fauna bridge at Taggets Hill

The overpass at Taggets Hill is functioning as a movement corridor and habitat for the koala and a range of locally occurring native fauna. Whilst introduced predators are also using the overpass as a movement corridor, the overpass provides good cover (albeit weedy) for small ground mammals to find refuge from predators. There are also ample trees for arboreal mammals such as the koala and possum to find refuge from predators, apart from a small area of shrubby vegetation in the centre of the overpass.

Four species of preferred koala food trees have been planted on the overpass and are more than 10 years of age. Koala food trees have also been planted on the eastern and western edges of the overpass and on the batters on the western edge of the motorway. There is also reasonable habitat to the east of the fauna overpass (although this habitat is not continuous with large areas of coastal bushland) and extensive habitat to the west of the fauna overpass. It is likely that the combination of existing habitat either side of the overpass, presence and age of planted preferred koala food trees and accessibility of the overpass from adjacent habitat are the key reasons that koalas are using this site. Based on results to date of koala crossings, koalas appear to spend more time west of the overpass and make occasional crossings, spending short periods on the eastern side before returning.

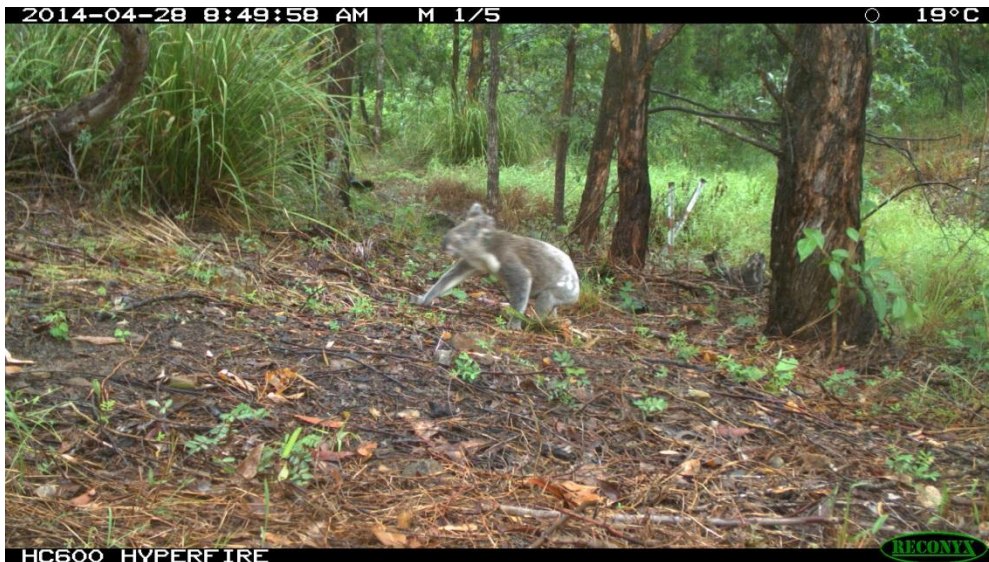
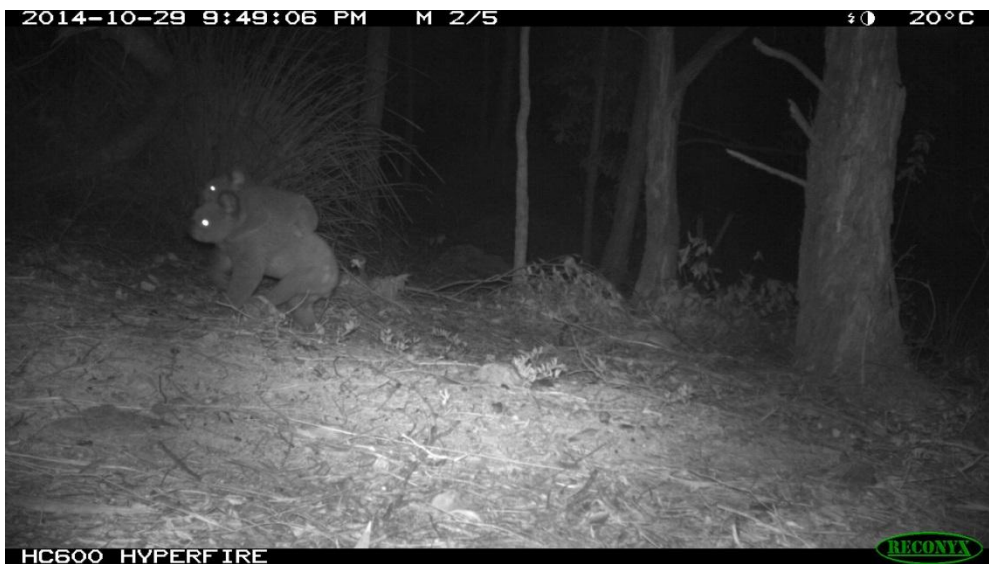
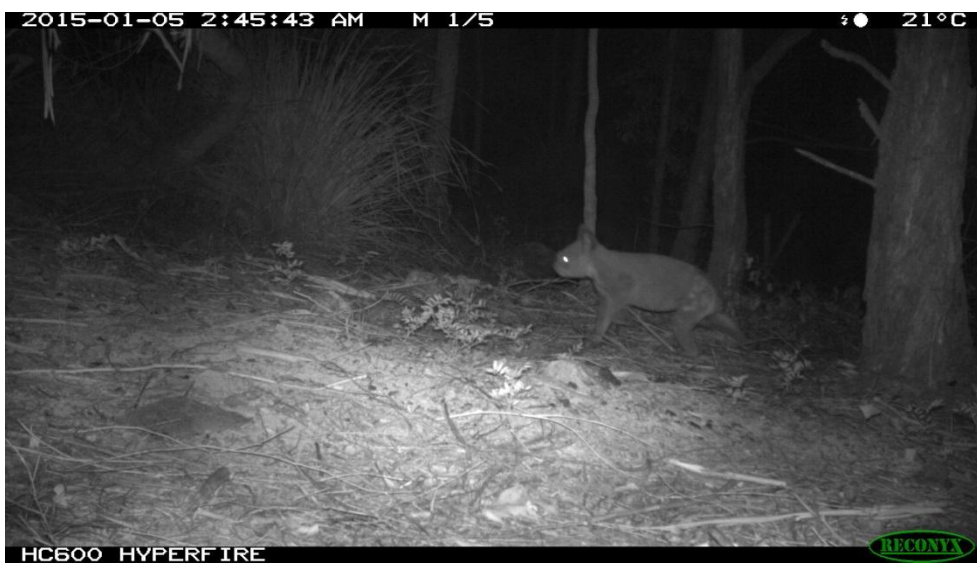
Plates 5 to 7: Four different koalas recorded on a single camera over the monitoring period

As noted above, a full analysis of all koala images and their rump markings has not yet been undertaken to determine exactly how many animals are using the overpass. Koala images recorded on the northwest camera (refer Plates 5 to 7 on Page 8) demonstrate how markings can be used to distinguish individual animals.

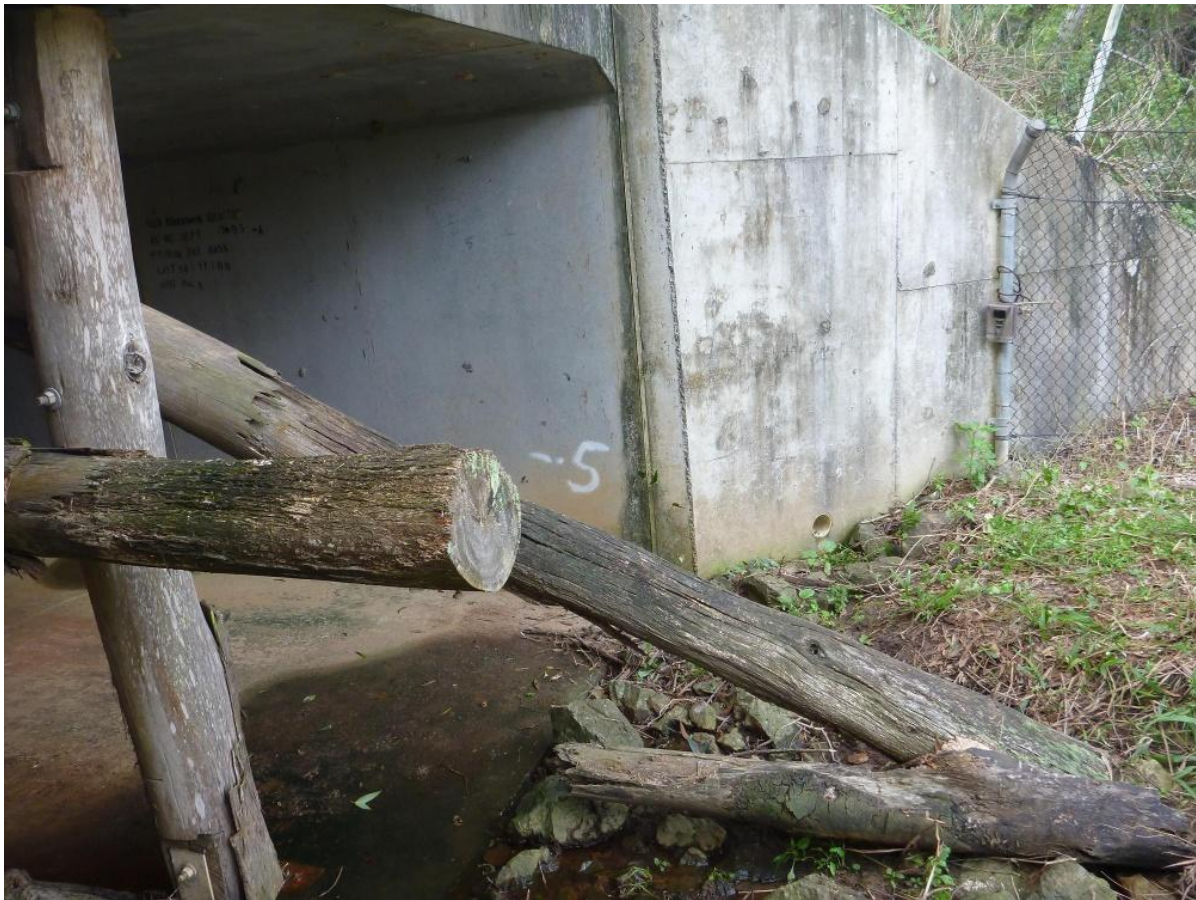
Termination of the fauna fence at the edge of the box culvert at Site 1. Short-eared Possums were recorded climbing over the fence and onto the top of the culvert.

At Site 1, Common Brushtail and Short-eared Possum were the most commonly recorded species. However this data set is very limited. Short-eared Possums were recorded scaling the fauna fence at this site, with potential for arboreal fauna to enter the Pacific Motorway. It is worth noting that the fauna fence does not extend along the top of the culvert, rather it terminates at each side of the entrance to the culvert. An image of the fauna fence has been included in Appendix 1.
